# *Guide to Conformal Coating & Cleaning Defects*

## Conformal Coating & Cleaning Defects

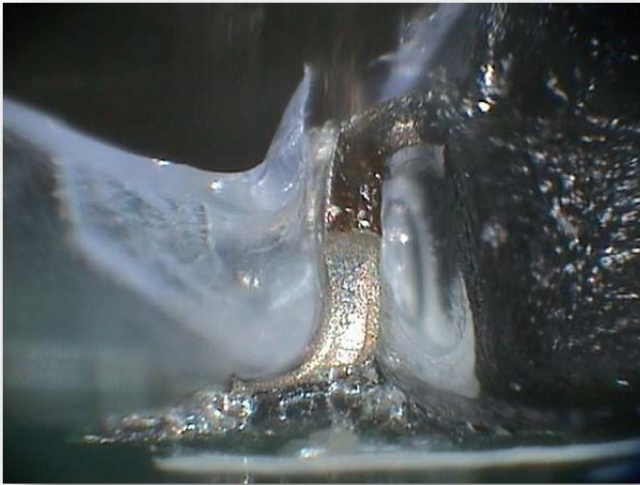
### PCB Corrosion

A coating can provide some level of protection in a sulphur environment but not all coatings provide this. In time sulphur gas can penetrate a coating. Removal of the coating shows evidence of corrosion. There have been a number of projects on the formation of sulphur corrosion products on printed boards. These were initially seen on silver finish boards close to the interface of the solder mask. In this area it is possible to have the silver and copper exposed. With a combination of dissimilar metals, sulphur, temperature and humidity similar formations have caused failures. There are two forms of this type of corrosion, blooms which form mainly due to the exposed metal surfaces and sulphur. The example above shows this along the pad and lead interface. Creep corrosion is where corrosion occurs across surfaces in higher humidity environments.

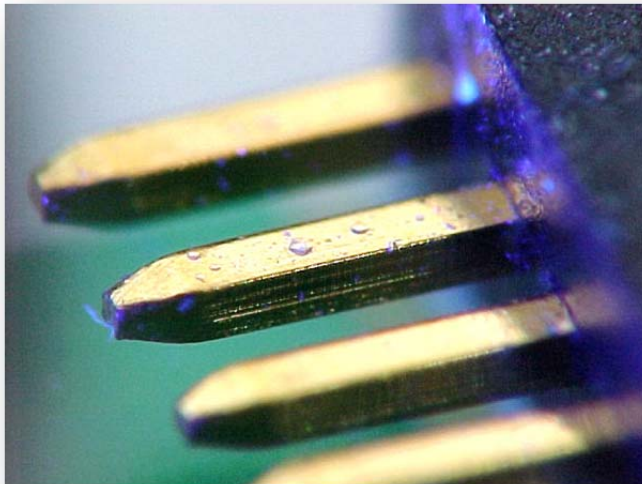
### Conformal Coating Contamination

Coating contamination was found under UV light inspection, the coating process has caused the material to contaminate the surface of the connector pins. This board assembly was coated with an automatic spray system which was probably incorrectly set up for production. The overspray is visible under UV light on the surface of the gold connector pins and the body of the part.

Rework of the connector pins in a UV inspection booth can be conducted using a cleaning fluid recommended by the coating supplier. The cleaning material should not damage the board assembly or the connector body. As gold contacts are inert there should not be an issue with contact resistance but other plated connector termination surfaces may need to be tested. It's important to run test boards or cards to check for correct set up and spray application then inspect the sample prior to running the process with product for the first time. It is not time consuming and can be conducted in less than 5 mins.

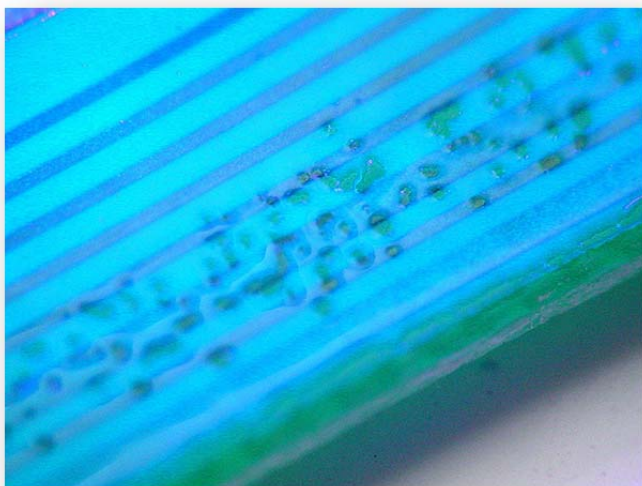
### Coating De-wetting

The coating is showing some de-wetting due to surface contamination on the surface of the solder mask. This would not be a general solder mask related issue but just local contamination possibly by handling. As this cosmetic defect is seen on the surface of the solder mask it should not be an issue but under most specifications it would be a cause for rework. The options would be to apply some more coating and cure or strip and recoat the board. This particular area of the board was always associated with V score lines from PCB fabrication and may be associated with contamination from the PCB manufacturing process.

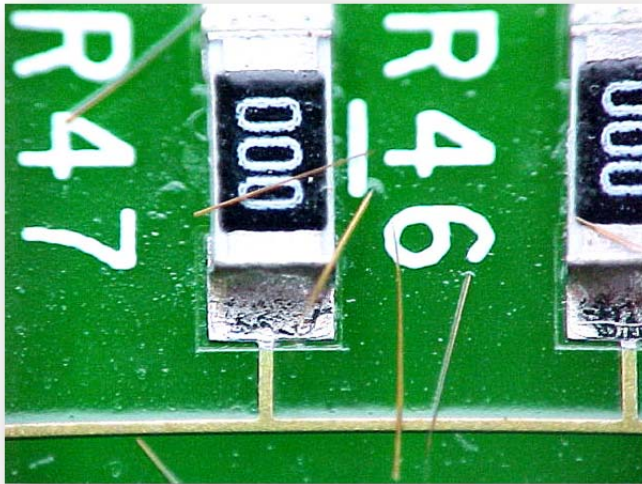
### Manual Coating Contamination

Manual coating a PCB is possible in small volume or after rework of selected areas. This can be conducted with a brush or spray can but needs to be conducted with care. Using a spray will probably require remasking selected areas on the board assembly hence brush application is attractive. Clearly manual application with a brush which is shedding fibres is very poor practice. Selecting a suitable non shedding brush is more expensive but if done correctly can be effective, provided the area is inspected after with a UV light source or the operation is conducted under UV.

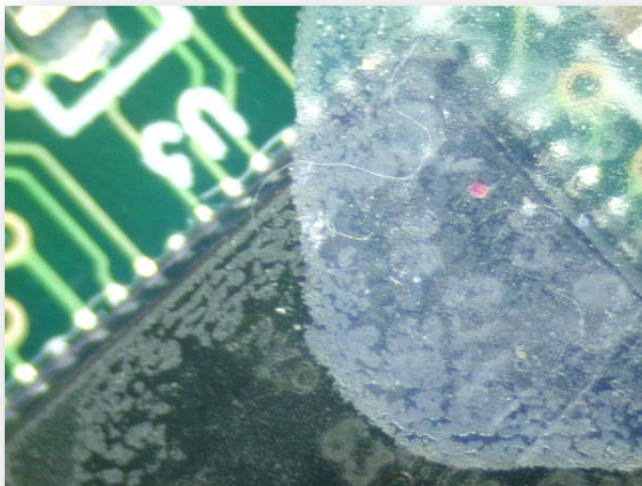
### Coating Lifting on QFN

Coating has separated from the surface of the plastic QFN/LGA body which is not uncommon on many plastic SMT parts. Devices often have release agents on the surface which make coating adhesion difficult to maintain, minor loss or separation may not normally be reworked. In this case the root cause should be established as all the coating has completely lifted. Cleaning the board assembly after soldering may overcome the problem in future production runs but equally it may not. The fault can be seen on most coating systems, more likely on thinner coating, although the poor adhesion will still be apparent on thicker coating that may not be easily displaced.

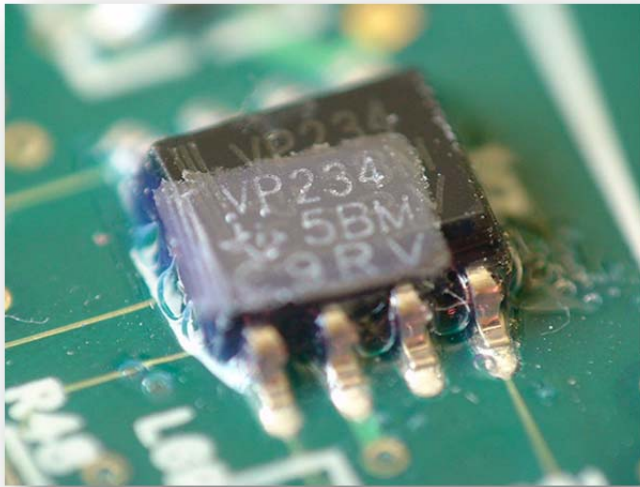
### Poor Coating Adhesion

Example of poor coating adhesion on the surface of an SOIC. This may be due to contamination on the surface of the plastic component as manufactured or due to contamination introduced during the assembly process. The interesting point on this example is the part removal of the component identification marking which is now visible in the surface of the coating. If the actual identification marking on the component body and the marks transferred in the coating were different we may be looking at a counterfeit component problem rather than just adhesion of the coating?

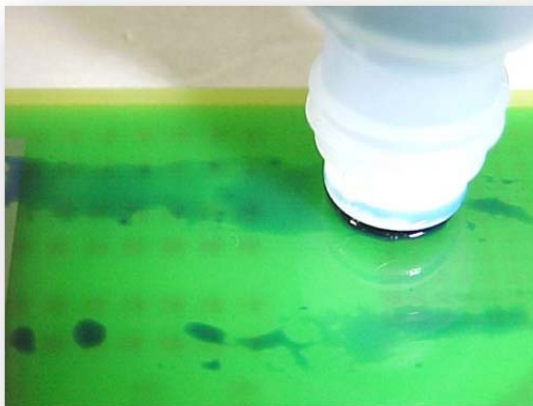
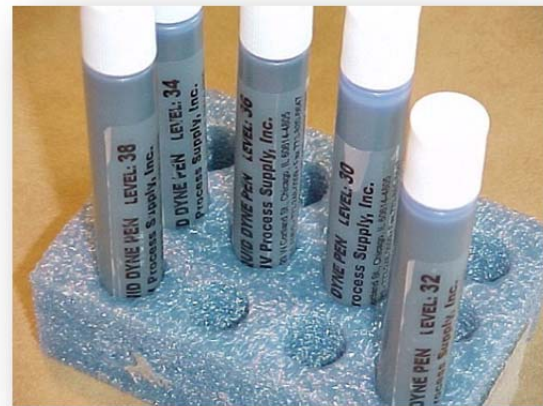
### Poor Solder Mask/Coating Compatibility

It is very important to specify the type of solder mask coating when purchasing bare printed boards, don't leave it to chance. Most coating material suppliers and contract assembly services will want to make sure the coating materials specified are compatible to avoid dewetting. All suppliers will provide recommendation on the range of surface tension measurements on the surface of a mask to be coated. The image shows a dyne pen being used to check the surface energy on a solder mask surface. Normally a set of pens will be used to confirm the wetting range, or not, based on different fluids in the pens. Remember also that the surface tension of a solder mask can change based on the assembly process the boards are subjected to during assembly.

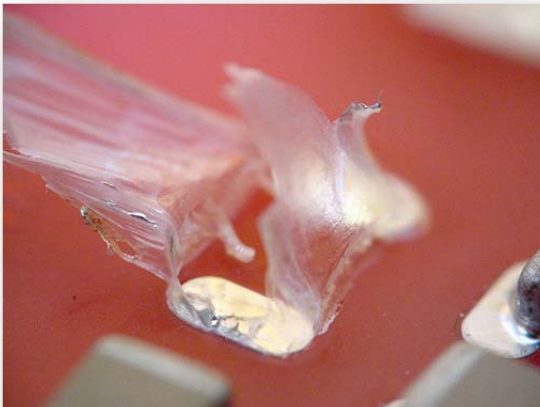
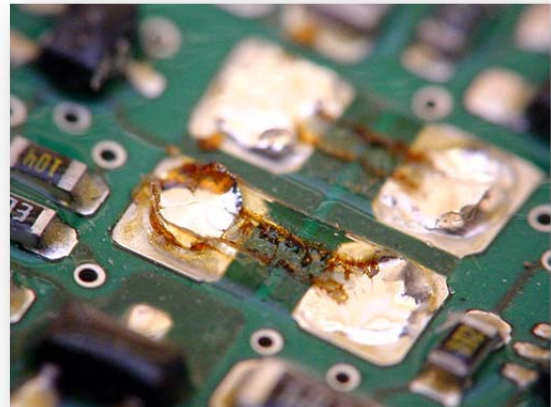
### Poor Rework of Coatings

There are different methods of reworking conformal coating; some create more mess and problem than others. In the examples above heating or soldering through the coating is quick but then requires further cleaning steps. The image on the left shows the lifting of the coating with the component when using thermal tweezers. On the right flux residues or the coating material has overheated during coating removal. IPC standards provide a number of different techniques based on the material type, coating thickness and rework operation required. Although more expensive, using abrasive coating removal is simpler and more versatile than thermal or chemical coating rework

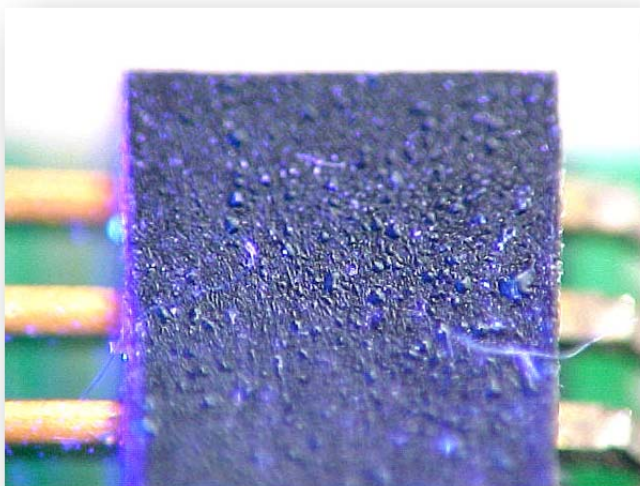
### Poor Coating Due To Overspray

Coating overspray is shown on the surface of this connector body during inspection under UV light. There was also evidence of contamination on the surface of connector pins which would be more of a practical issue than the connector body. Coating material on the surface pins may lead to high resistance or intermittent contacts. The board assembly had been spray coated and it is likely that the spray patterns and coverage area had not been correctly defined.

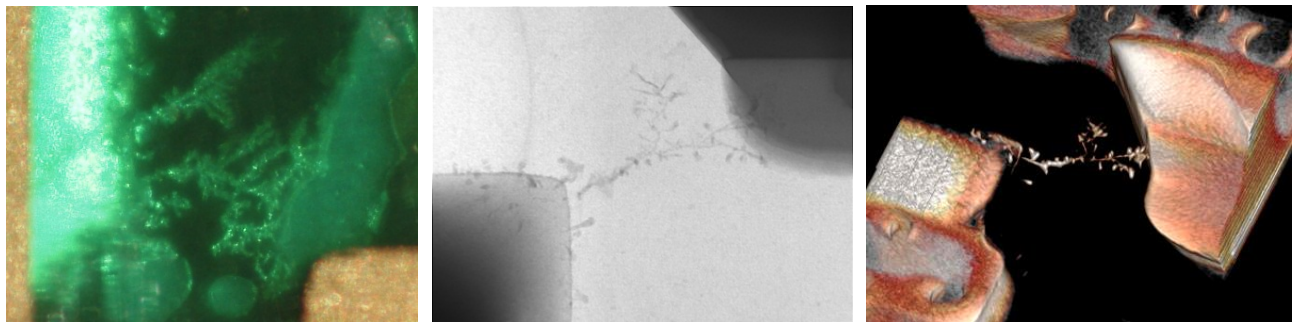
### Copper Dendrites/Surface Corrosion

Three dramatic examples of copper dendrites formed on the surface of printed circuit board assemblies. In each case they lead to intermittent failures in the field. They are not specifically lead-free process related but can occur if the correct controls are not maintained in a manufacturing facility; some engineers have reported this failure mode in lead-free when moving to VOC free fluxes. Copper dendrite will occur with a tin/lead and lead-free process and need to be analysed to find the root cause of the problem. The examples show the formation of a copper dendrite/fern between two conductors. This fault may occur when flux residues remain on the board surface and are then subjected to high temperature and humidity. A circuit with a voltage applied of 5-10 volts can then allow the formation of a conductive path on or through the moisture layer.

**Copper dendrites, one of the most common failure modes, and three ways of seeing the same failure**

A copper dendrite often creates an intermittent fault which can be very difficult to pinpoint. Examples like these can be seen under and over solder mask coating or under conformal coating when there is poor surface adhesion of the coating hence the contamination on basic printed board is important. Contamination testing and Surface Insulation Resistance (SIR) assessment are two techniques often used to monitor and control the levels of harmful contamination or assess the assembly material's performance on finished products to help avoid the possibility of corrosion.

Contamination that causes this failure mode is not only from the flux, it can come from the level of cleanliness of the printed board prior to use. It can also be caused by the design of the board, the way it is mounted in a product and exposure to changes in temperature and humidity. Three different techniques were used to investigate the failure shown above. The first image shows back grinding a microsection up under the chip component to avoid removing the evidence of failure as so often happens in test departments. Standard high resolution x-ray was used in the second example after the location of the product failure had been established. This technique was used to examine for failure in similar locations on other products. Using x-ray with CT capability allowed a three dimensional view and a clear understanding of the position of the dendrites without sectioning.

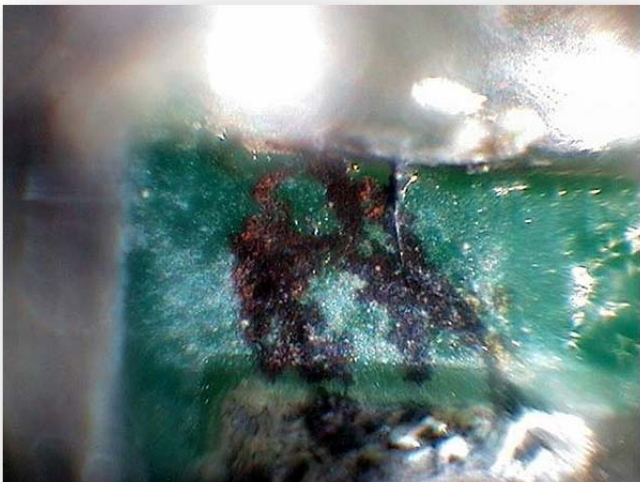
### Copper Dendrite Failure

Coating failure has occurred allowing the copper dendrites to form across the surface of the solder mask between two terminations. This was found after removing the coating during failure analysis of the circuit board. Either the soldering materials used or the cleanliness of the basic PCB was inadequate for the product environment. Comparing the soldering materials, process and coating combination can be conducted using a standard test board and measuring Surface Insulation Resistance (SIR) when exposed to a controlled environment.

Copper dendrite formation is one of the most common failure modes experienced in no clean or under conformal coatings. The dendrites, however, are often missed when engineers try to remove the coating to investigate failure. Correct failure analysis techniques are often not used hence no fault found

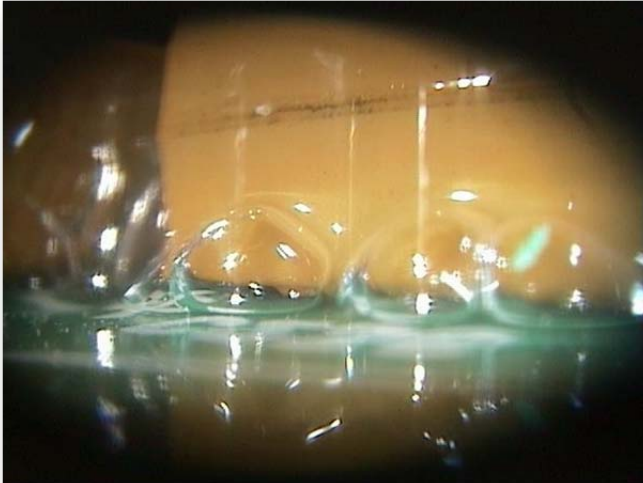
### Coating Bubbles “Bug Eyes”

Conformal coating bubbles or, as I would call them “Bug Eyes” due to their size, are caused by entrapped air or other material outgassing from under parts. It is also possible to get these by fast/force curing the coating before the solvent has had time to evaporate or air to escape. If present across a row of termination points it will be a reliability problem as the coating will not offer any protection. It will in fact allow a moisture trap if the product is in a high humidity environment and possibly lead to failure.

This would not be acceptable under any current specifications.

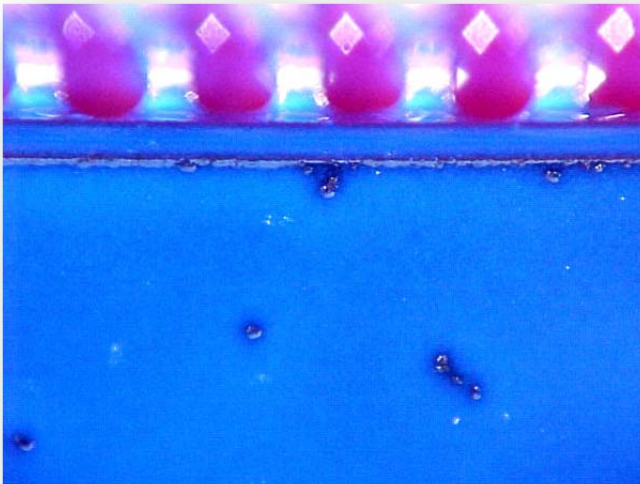
### Minor De-wetting or Bubbles

Coating has not wet to small areas on the top surface of a plastic surface mount IC. This may be contamination on the surface, however non wetting would be more pronounced. The limited coverage seen on the edges is standard and commonly seen. A high solids material or repeating the coating process would overcome the limited coverage on the edges but only cover over the voids making them look more like bubbles.

If the coating is satisfactory on all other surfaces where there are connections between terminations, slight blemishes do not really matter or impact reliability and are totally a cosmetic issue.

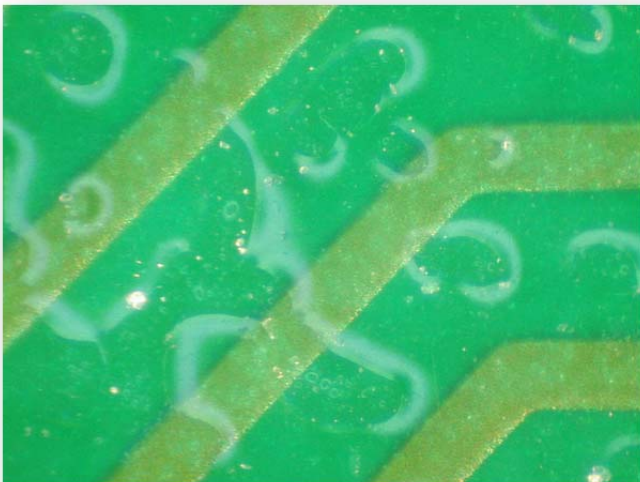
### PCB Surface Contamination

Poor manual handling of the board assembly prior to coating has resulted in poor coating adhesion. Boards should always be handled by their edges after cleaning or in a no clean assembly process. Contamination on the surface of the board may have come from other sources and needs to be reviewed and the product re-cleaned. The solder mask and its compatibility with the conformal coating should be reviewed with adhesion tests. If the board has been through a cleaning process the solder mask may have absorbed material from the cleaner and need time for it to evaporate from the surface of the mask prior to coating. Always consider baking the board assemblies before coating.

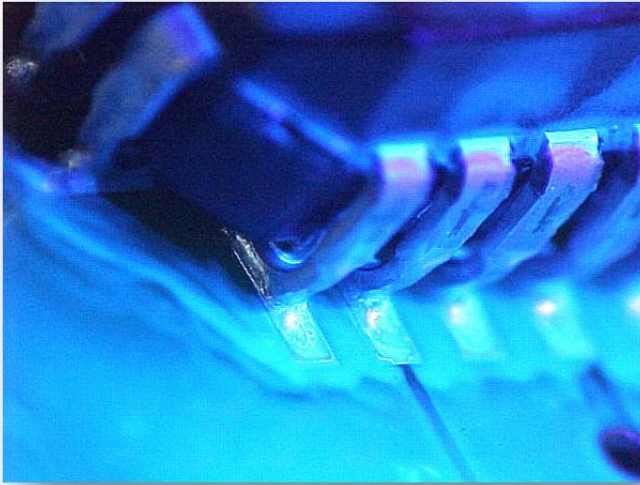
### Coating Capillary Action

Coating inspection under UV light shows the impact of capillary action, although there is evidence of coating coverage on the board and component surfaces coating has capillaries under the PLCC. This is indicated by the tide line around the component, based on inspection criteria, this still meets common standards but the thickness of the material will vary on the surface of the board. Changing the viscosity of the material, reducing the travel speed of the spray, increasing the amount of material or solids applied during spray application should improve the results.

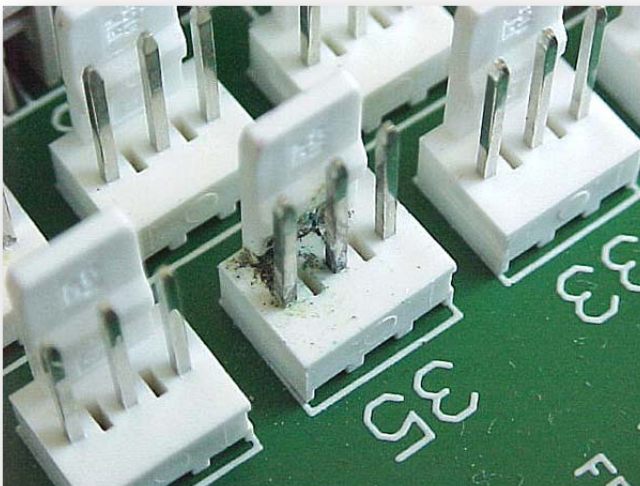
### Corrosion Dendrite Formation

Corrosion and dendrites have formed across the surface of the plastic connector body between two terminations. This was caused by excessive flux being sprayed on to the top surface of the board. The flux could have penetrated up through the connector by capillary action between the pin and connector body. In the case of no clean materials they need to be exposed to the correct preheat to allow full evaporation of the carrier solvent and deactivation of the flux. If a coating had been used in this application the same problem could have occurred on other sections of the board. Coating cannot overcome poor production set-up or control when potentially corrosive materials are still on the surface of the board.

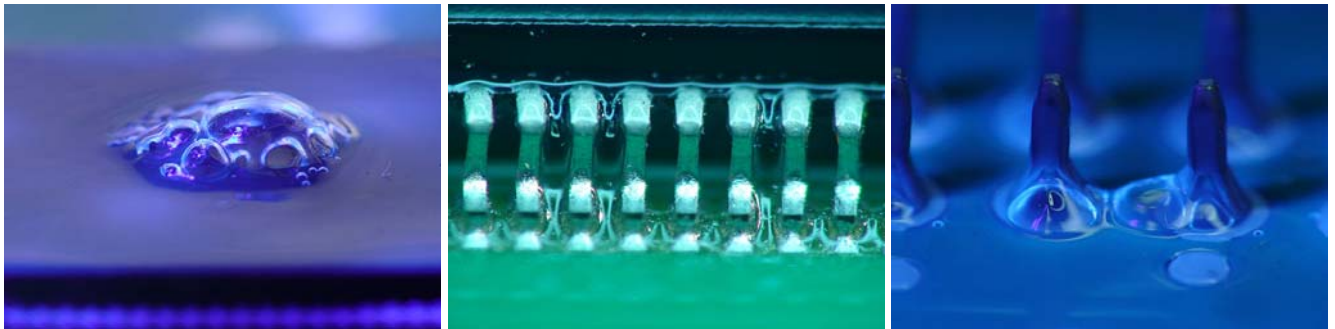
### Coating Bubbles

Bubbles in the coating surface are not uncommon, the criteria is covered in different industry specifications, the key issue is where the bubbles are positioned. If they are between terminations, tracks and solder joints they can potentially allow a reduction in insulation resistance and would be unacceptable.

If, however, they are on top of large components or on the surface of the solder mask not above tracking they should not be an issue. However, many people and specifications state this to be a rejected regardless of the area that is affected and if the assembly is fit for purpose. Some companies actually place a size criteria on the bubbles based on their location. It's a pain to measure these but also a pain to strip and recoat! Bubbles are most commonly related to hold and cure time with the inability of solvent to escape or trapped air still to be displaced. If this occurs on a stable dip process look at what process parameters have changed, something must have changed!!

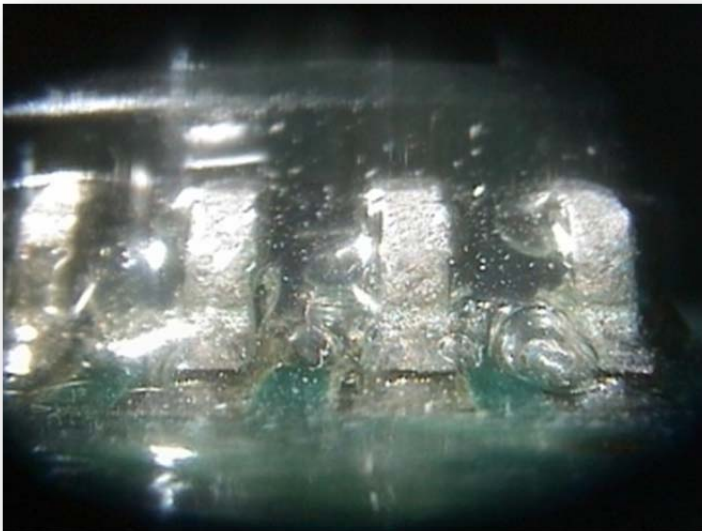
### Coating Bubbles/Incomplete Coverage

Coating bubbles or voids, regardless of the name are not acceptable as clearly the coating does not provide any protection between the two termination points on this SOIC. This and other positions like it may be down to local contamination in specific areas on the solder mask preventing the surface wetting during dip coating. It may also be the case that this product has been reworked leaving flux on the surface of the board.

The coating has wet the component terminations, the component body but not the surface of the mask. If contamination of the surface is to blame there should be other areas like this one example.

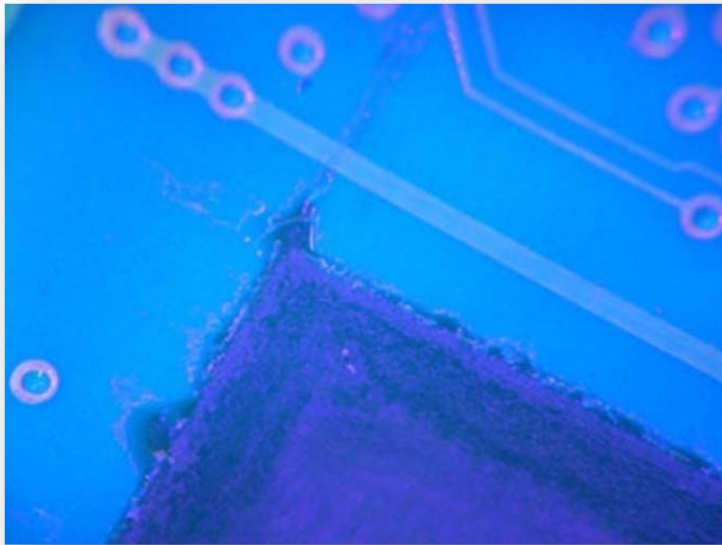
### Incomplete Coating Removal

Coating rework can be difficult and time consuming so every effort must be made to make sure the process is well controlled and a first off is always inspected prior to working on a long batch of work. In the example a selected area of the board is being reworked with a solvent stripper and masking tape is being used to define the area.

After stripping and inspection under UV light it is clear that the coating has not been fully removed which may be acceptable or unacceptable for a given application. There are other coating removal methods which may be faster and more successful like abrasive jets which provide a cleaner option. Selecting the right masking tape is important to reduce the amount of solvent seeping under the mask. It should be removed as soon as possible to prevent further attack of the main coating.

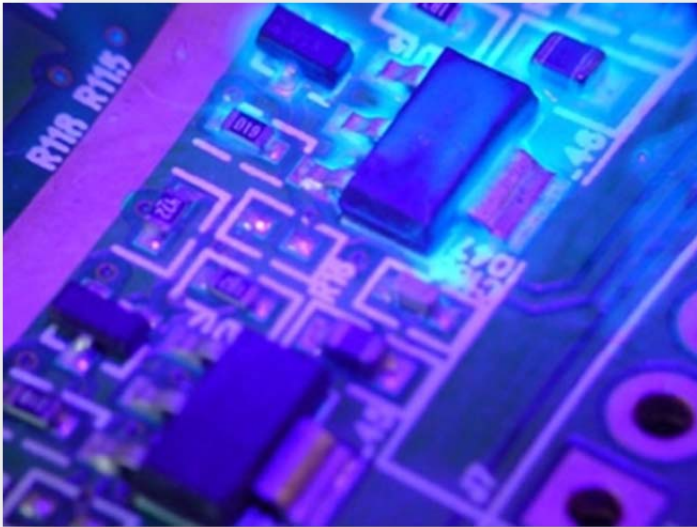
### Coating Removal for Rework

Coating inspection is being undertaken under UV light after chemical stripping. Rework is being conducted on the board assembly prior to surface mount component removal. It is often easy to solder through a coated board with selected materials. However, the coating will char, leave residues, require cleaning and need to be conducted under suitable extraction. If the coating is too thick contact heating is less effective than the preferred technique.

The example board shows one area which has been cleaned and the top area is not fully stripped. It is virtually impossible to remove coating from under components. This can make component removal more difficult just like using adhesive. The trick is to raise the temperature of the board assembly above ambient even when using contact tools where you can apply a small twisting action to the body of the part.

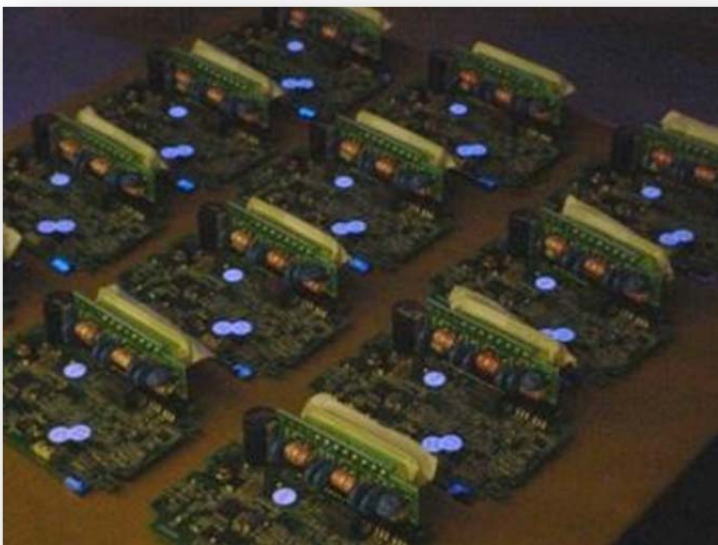
### Unsatisfactory Masking

Masking board assemblies prior to coating is unfortunately a common practice during conformal coating. More consideration at the design stage would reduce the need for masking, which is often difficult and always time consuming.

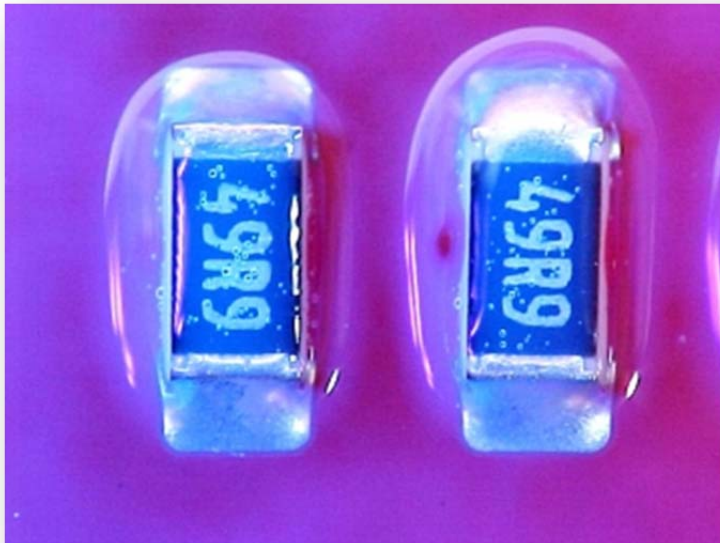
### Incomplete Coating Coverage

The conformal coating has not encapsulated the side of these two resistors which were manually sprayed. Manual spray fluxing can give a satisfactory coating performance, although it will vary in thickness. When manually spray fluxing boards apply the coating from one direction at approximately 45deg, and then repeat the spray coating in three additional steps after first rotating the boards through 90deg. Try to avoid applying excessive coating in any one step. During manual spray fluxing it is good practice to check the area of coverage on a test surface then inspect under UV light. This provides a simple method of looking at the spray width, consistent coverage and some comprehension of the amount of coating applied with any one spray stroke

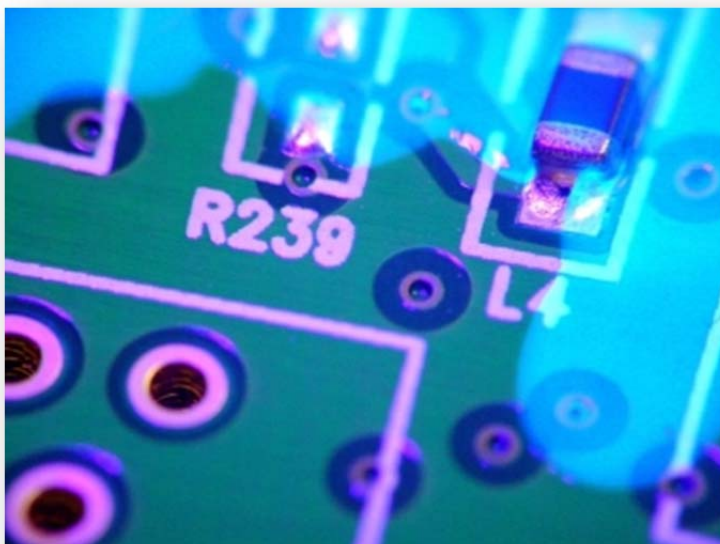
### Poor Coating Application

Coating on the board assembly should have had a straight edge; it is not clear why the uneven application line has happened in production. The coating was applied using an automatic spray system and previous example boards were satisfactory. Running a blank test board or test cards prior to coating fully populated boards should be standard practice before running a production batch.

The cost of contract assembly is often all about the masking/demasking process and not the cost of coating or materials. Making sure that every point that does not require coating has been protected can be made easier. For manual spray coating boards are often placed on a rotary table and in a UV coating booth. If all the boards are located in lines and the masking tape used has a UV trace or naturally fluoresces it can make inspection for missing masking very simple before spraying unprotected surfaces. Missing dots are then fairly easy to spot; can you see the missing dots?

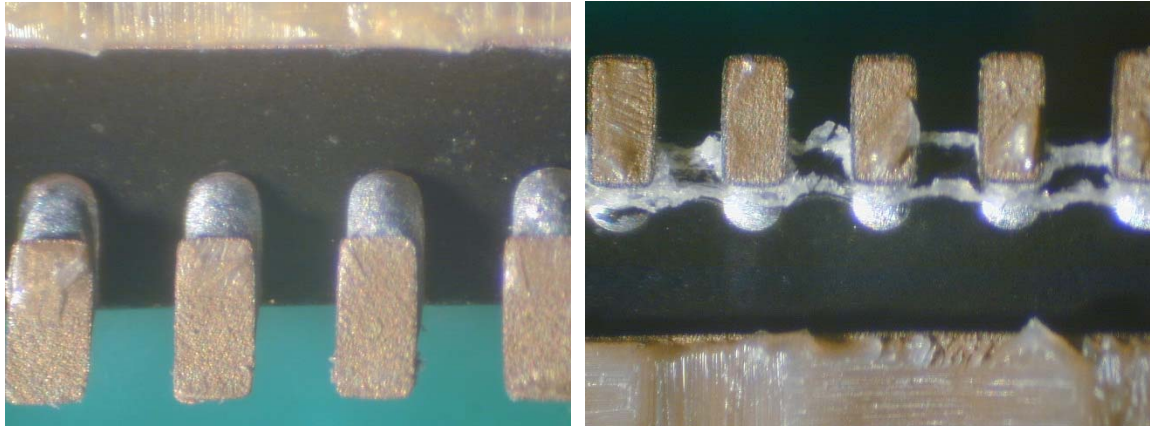
### Cleaning Under QFN

Successful cleaning under low stand-off height QFN packages can be achieved as shown on the first image below; poor flux and cleaner compatibility is shown on the second. Both were cleaned in a batch process using different process recipes. The sample parts were removed from the surface of the board mechanically to show the process performance.

Modification to the design rules for a component can also increase the reliability of the cleaning process and, if marginal, also reduce the risk of failure. Increasing the distance between the termination pad and centre pad, and eliminating solder mask under the package can also help cleaning performance.

The key to evaluating residue removal is the solubility of the residue in the cleaning material before undertaking the actual cleaning trials. When this is established then the correct cleaning process can be defined to allow full penetration under the components of the cleaning chemistry before confirming that it can also be removed during the rinsing phase of the process.

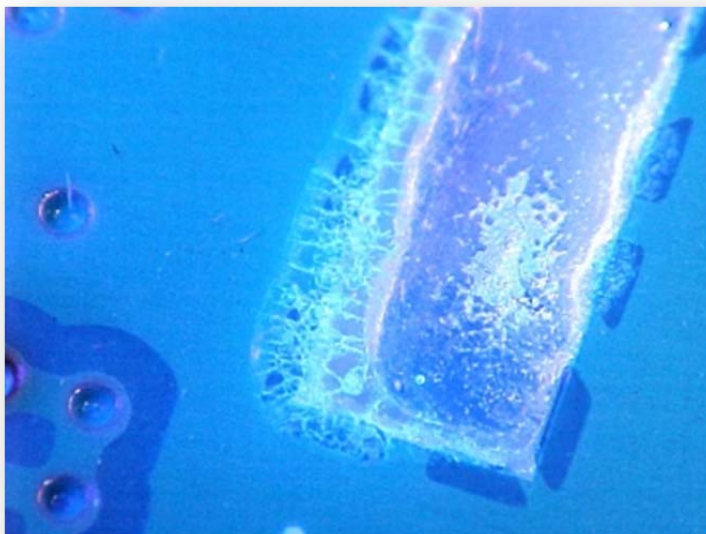
### Conformal Coating Lift

Coating is lifting around the edge of the pad. A reaction has taken place with the flux under the coating. Inspection showed this to be visible under all of the termination points after reflow soldering so it is assumed to be related to the residues left on the joint areas

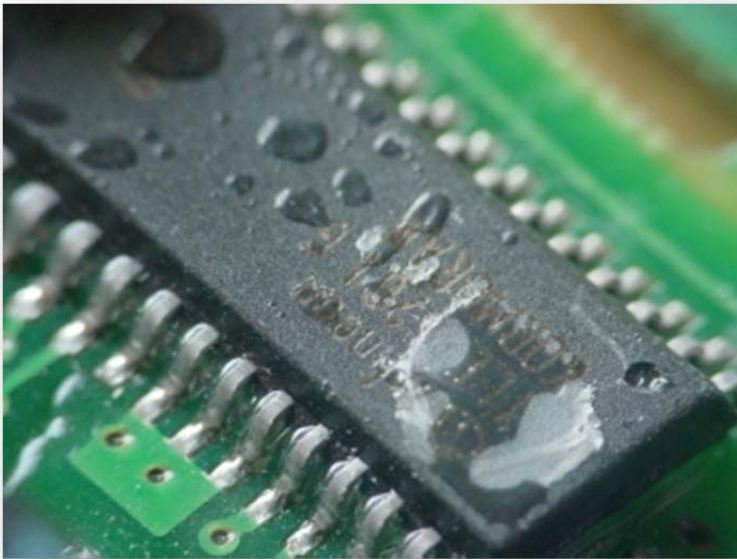
### Poor Conformal Coat Wetting

The coating has not wetted the surface of this plastic IC which is not uncommon. The Small Outline Integrated Circuit (SOIC) may have some contamination on the surface of the plastic. Mould release agents are often suggested as the main cause of de-wetting on ICs and it is difficult to eliminate this unless the product is going to go through a defined cleaning process.

It is suggested that minor de-wetting is acceptable provided all other inspection criteria are met. The example shown would not be considered minor. The main coating requirements are all terminations, adjacent pads, and exposed terminations be coated to a defined minimum thickness with no bubbles between the terminations with minimum design clearances. This does, however, contradict existing quality standards that have not been reviewed for many years.

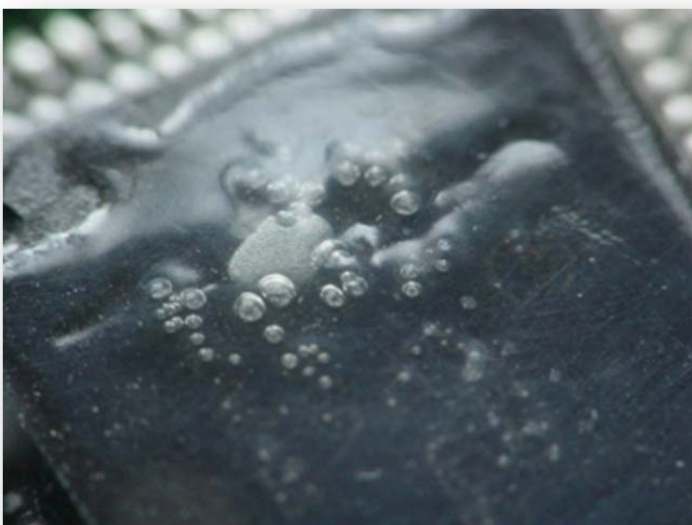
### Excessive Coating Thickness

The conformal coating applied in this example is excessive which has probably lead to the bubbles forming during cure. The excessive thickness allows the outer surface to dry and form a skin which does not allow further solvent in the bulk of the coating to evaporate allowing the bubbles to form.

If bubbles are only visible on the top surface of the Quad Flat Package (QFP) they should be considered a cosmetic defect, not requiring rework. Modifications should be made to process parameters rather than reworking the product. There is also some pull back of the coating on the edges of the component, possibly due to the thick deposit on the top of the device.

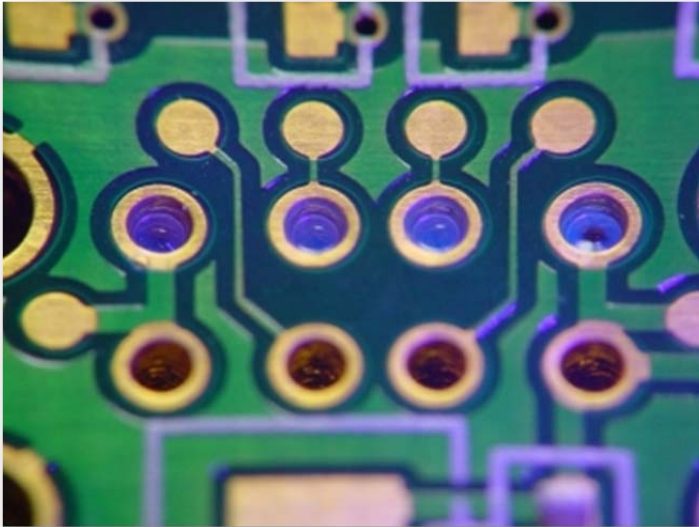
### Conformal Coating Penetration

Coating has penetrated through holes to the opposite side of the board due to the process parameters or the viscosity of the material. This may not be an issue but if this contamination could cause a problem in manufacture the holes should be masked, this could be a permanent mask sealing the holes to eliminate removal.

Changing the process parameter on the spray system could be considered along with the solids content of the coating material or the hold time prior to full curing. A short cure time may not allow the coating to tack dry. If the coating thickness is excessive the surface will flash dry leaving the liquid coating to drain through the holes during the hold period. The best solution is masking to guarantee the process reliability.

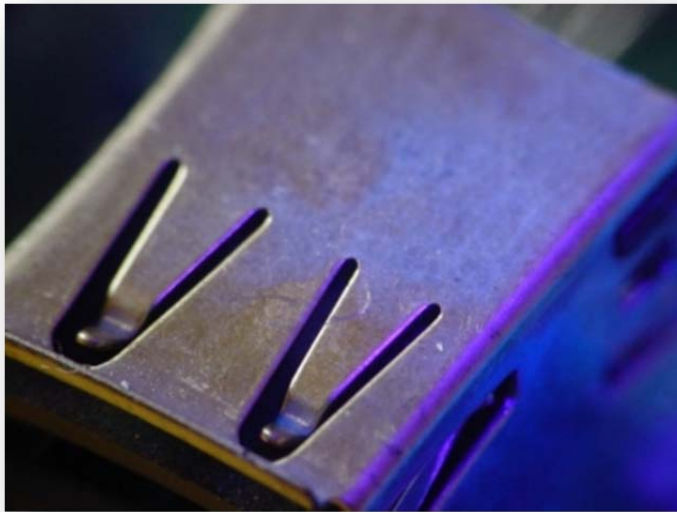
### Coating Overspray

Coating overspray has been detected during inspection under UV light. The outer case of this connector shows evidence of the coating which may be due to incorrect programming of the robotic spray system. Although the connector could be masked this adds to the time and cost in manufacture.

Even if the engineer's programming is correct, changes or fluctuation in process parameters may be the root cause of the problem. However, variations in the positioning of the product on the equipment may be a contributing factor to the contamination. Although using a standard blank board can be used for machine set-up and optimisation, an assembled board must be used for machine program confirmation.
