## **Low Temperature Solder Joint Inspection Criteria**

## **High Temperature Solder Joint Inspection Criteria**

## **High Temperature Assembly & Soldering Defects**

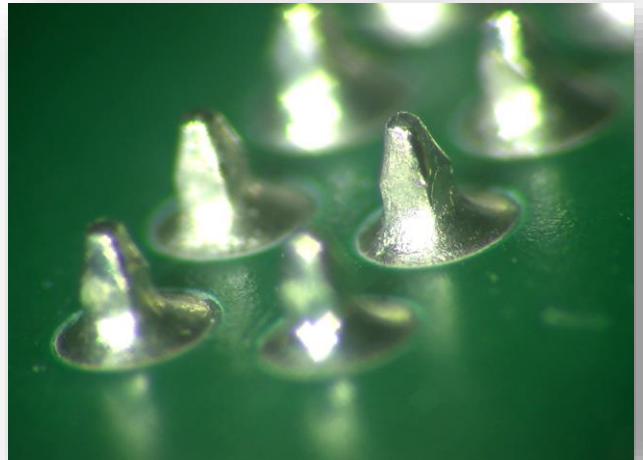
### **Satisfactory**

Solder joints produced with Tin/Bismuth/Silver (SnBiAg) with a robotic soldering process at 240°C. Although the solder does not cover all of the pad surface, this is perfectly acceptable solder joints

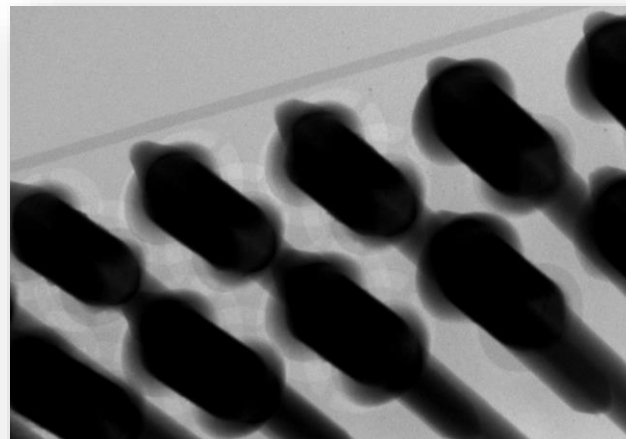
### **Satisfactory**

Satisfactory joints formed with SnBiAg solder alloy during robotic soldering. X-ray inspection was used to show the degree of the through hole fill on a copper OSP finish printed board assembly

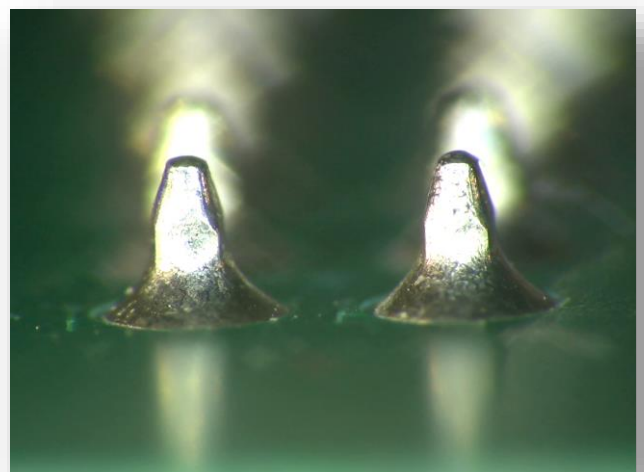
### **Satisfactory**

SnBiAg solder joint produced with a robotic iron soldering process at 240°C. The solder has formed a perfect solder joint with a concave fillet formation

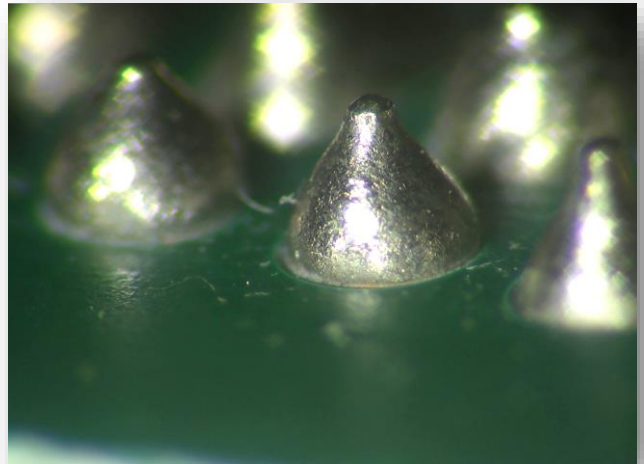
### **Satisfactory**

Solder joints produced with Tin/Bismuth (SnBi) on a robotic soldering process at 240°C

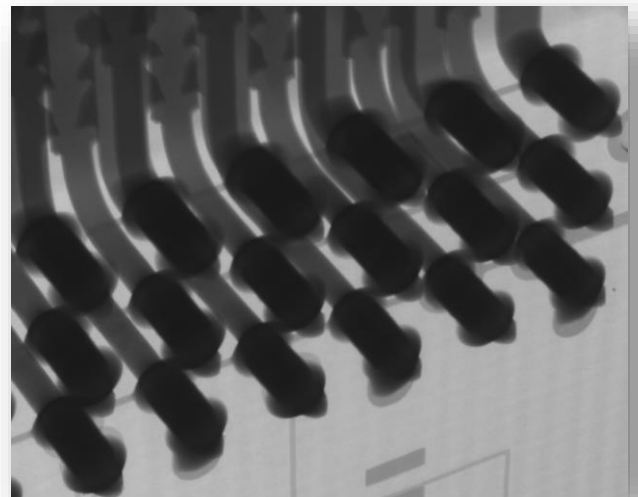
### **Satisfactory**

Satisfactory joints formed with SnBi solder alloy during robotic soldering. X-ray inspection was used to show the degree of the through hole fill on a copper OSP finish printed board assembly

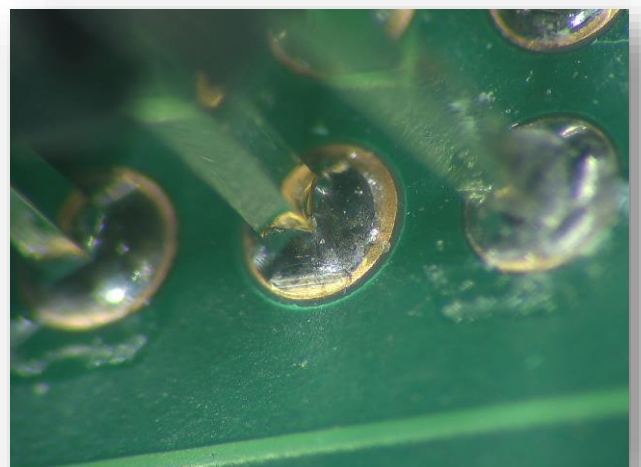
### **Satisfactory**

Solder joint produced with SnBi alloy and a robotic iron soldering process at 240°C. The solder has formed satisfactory solder joints on the top side of the board. The solder has not fully wetted the nickel/gold pad surface

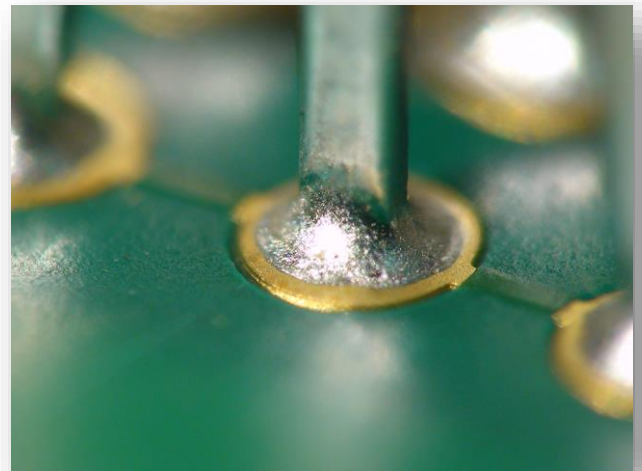
### **Satisfactory**

Solder joints produced with SnSb on a selective soldering process at 340°C. Although the solder does not cover all of the gold pad, this is perfectly acceptable

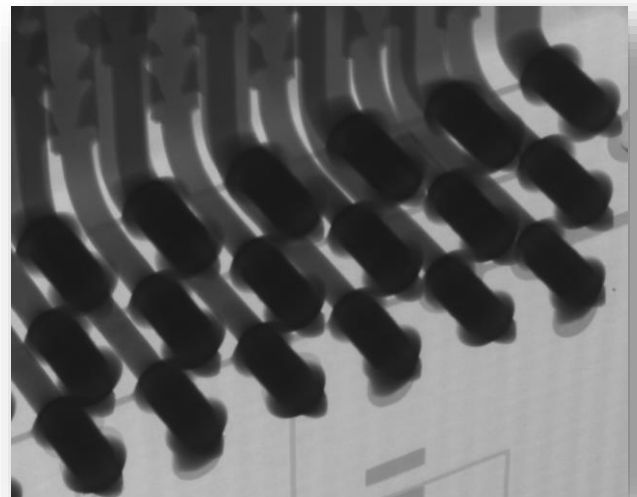
### **Satisfactory**

Satisfactory joints formed with SnSb solder alloy during selective soldering. X-ray inspection was used to show the degree of the through hole fill on a gold finish printed board assembly

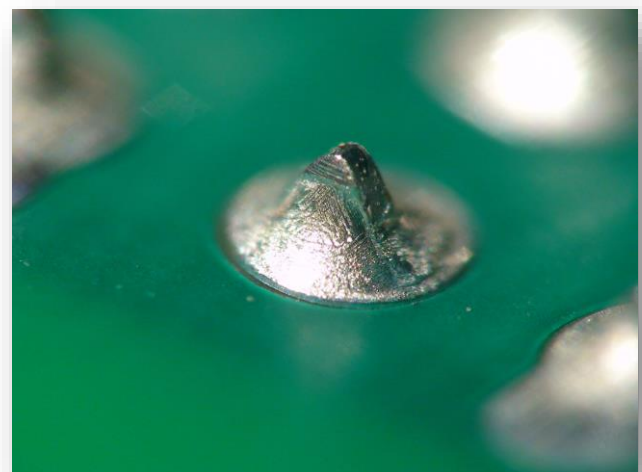
### **Satisfactory**

Solder joints produced with SnSb alloy and a selective soldering process at 340°C. The solder has formed a perfect solder joint with a concave fillet formation

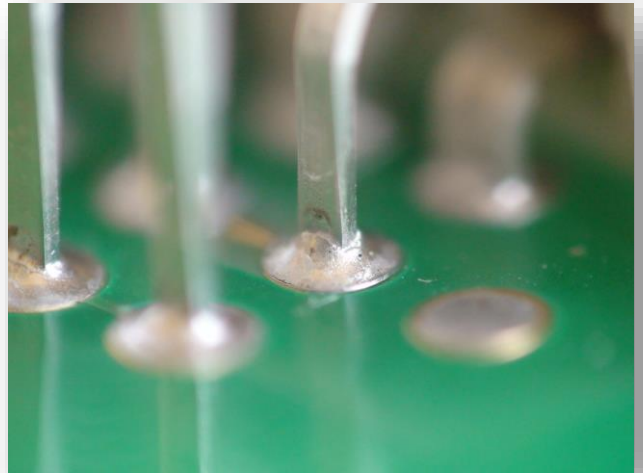
### **Satisfactory**

Solder joints produced with High Melting Point (HMP) on a selective soldering process at 360°C. The solder has filled the plated through hole and wetted the surface of the pad

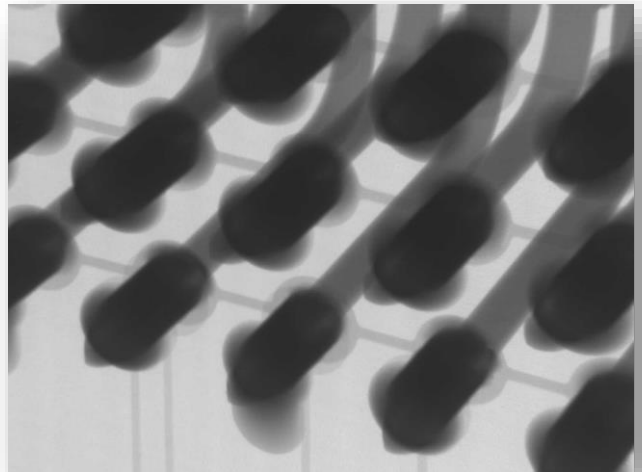
### **Satisfactory**

Satisfactory joints formed with HMP solder alloy during selective soldering. X-ray inspection was used to show the degree of the through hole fill on a gold finish printed board assembly

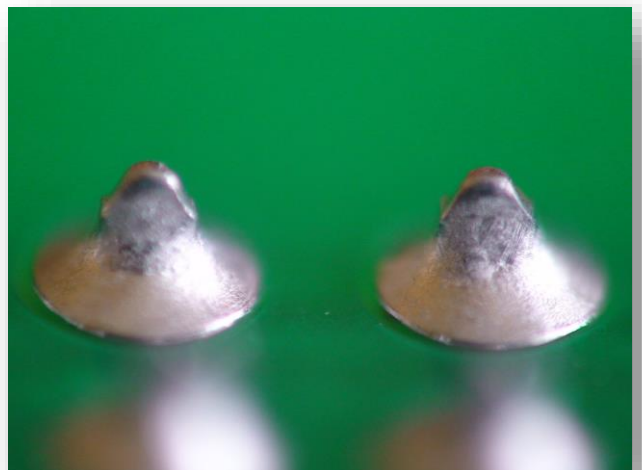
### **Satisfactory**

Solder joints produced with HMP alloy and a selective soldering process at 360°C. The solder has formed a perfect solder joint with a concave fillet formation, the satin finish on the joint is not uncommon on this alloy

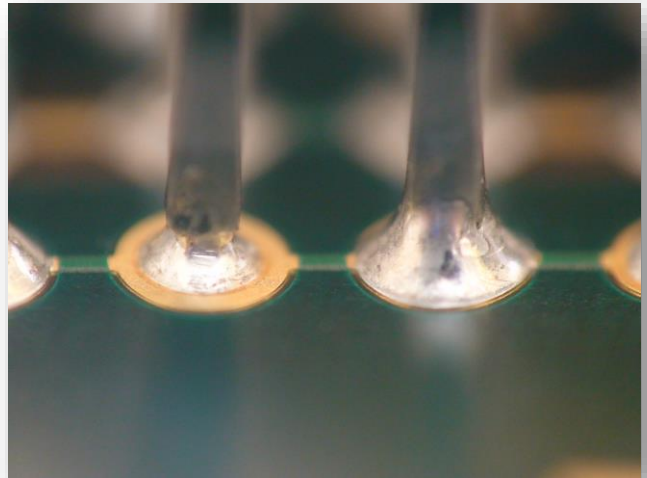
### **Satisfactory**

Solder joints produced with tin/copper on a laser soldering process. Although the solder does not cover all of the pad, this is perfectly acceptable. There is variation in the solder volume per joint which is not uncommon with automated wire feed process

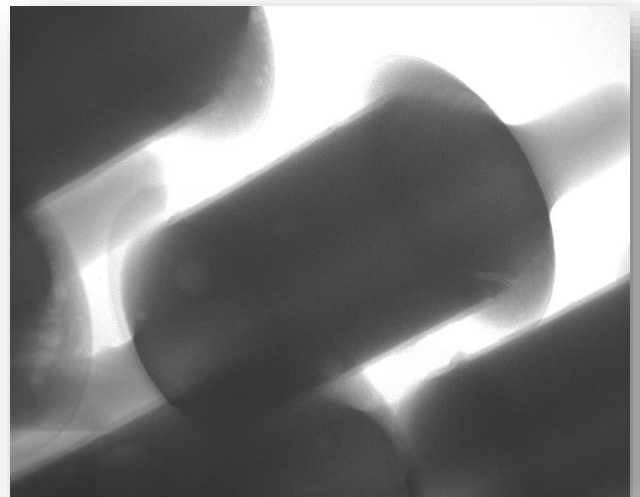
### **Satisfactory**

Satisfactory joints formed with tin/copper with laser soldering. X-ray inspection was used to show the degree of the through hole fill on the printed board assembly

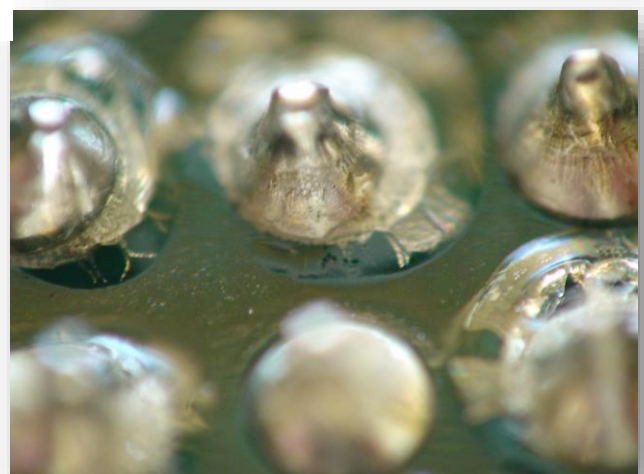
### **Satisfactory**

Solder joints produced with tin/copper with laser soldering process. The solder has formed a perfect solder joint with a concave fillet formation. There is excess flux present on this example but if cleaning is used this would not be a problem

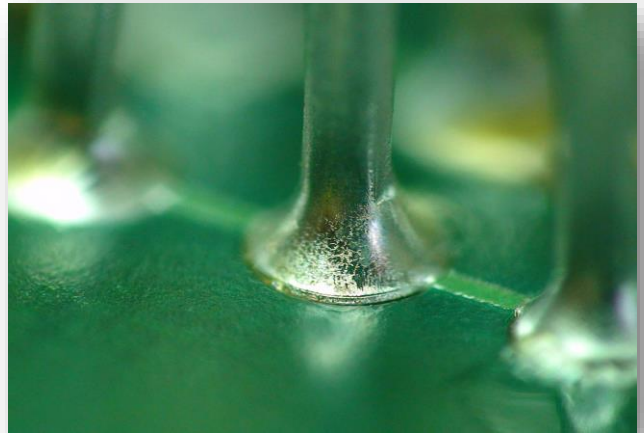
### **Satisfactory**

Solder joints produced by robotic iron soldering using tin/copper alloy with good solder penetration

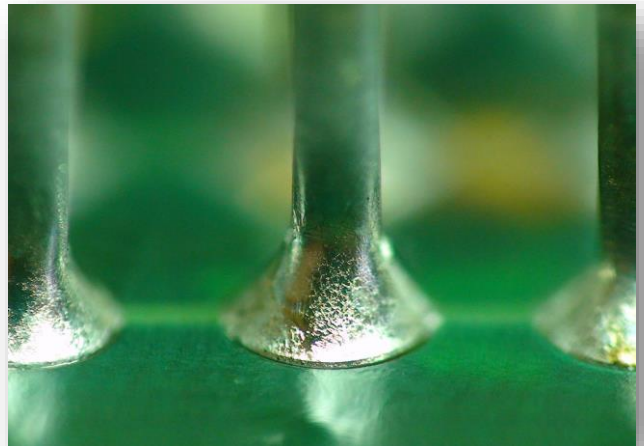
### **Satisfactory**

Solder joints produced with tin/copper and robotic iron soldering. The solder has formed a perfect solder joint with a concave fillet formation

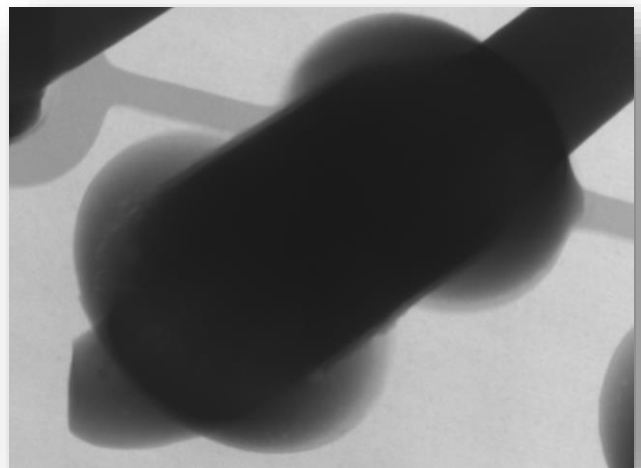
### **Satisfactory**

Satisfactory joints formed with tin/copper and automated iron soldering. X-ray inspection was used to show the degree of the through hole fill on the printed board assembly

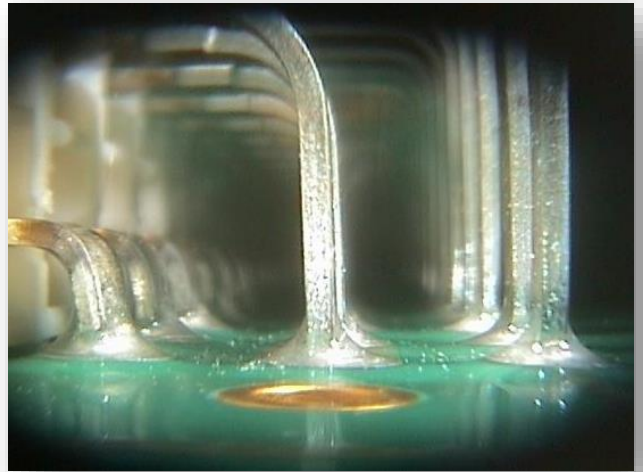
### **Satisfactory**

Solder joints formed with tin/copper/nickel solder paste and intrusive reflow. The solder fill and wetting are satisfactory on the gold finish

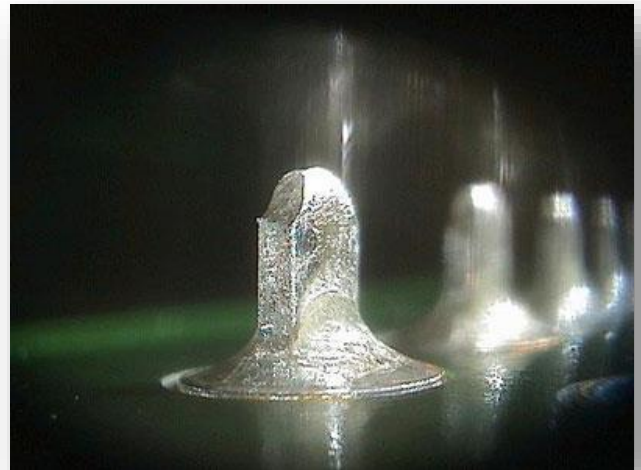
### **Satisfactory**

Intrusive reflow joints using tin/copper/nickel solder alloy reflowed in air

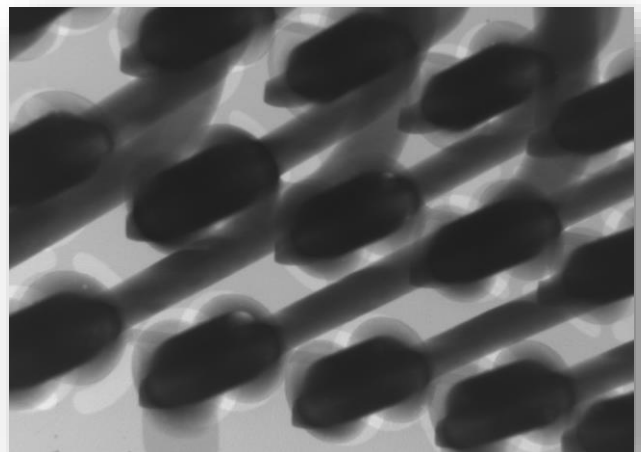
### **Satisfactory**

Solder fill on plated through hole under X-ray inspection. The solder fill exceeds 100% of the barrel

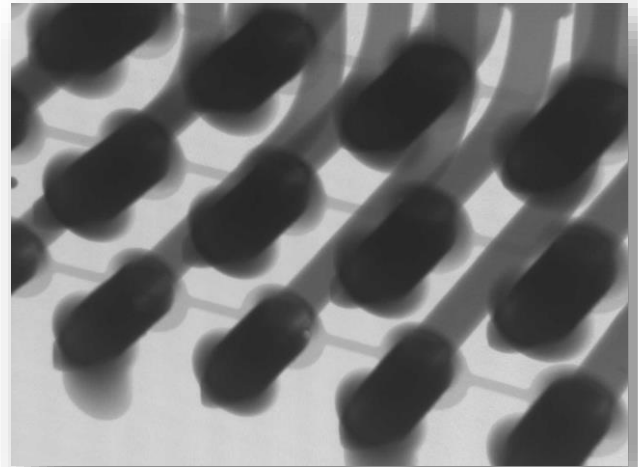
### **Unacceptable**

Solder joint produced with SnCu during laser soldering. The X-ray inspection shows some variation in fill of the plated through holes and negative solder fillets on the nickel gold board. Variation in solder wire feed needs to be considered

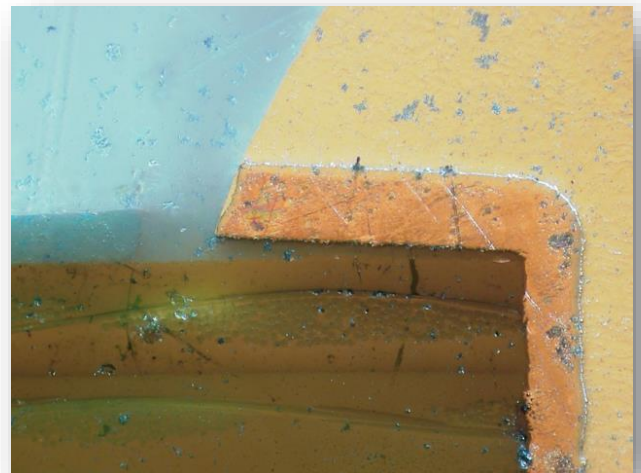
### **Unacceptable**

Solder joint produced with SnCu and soldered with a robotic soldering iron. The soldering iron temperature, dwell time or pressure may have caused the pad to lift from the surface of the laminate or it is a function of PCB expansion and contraction and should be investigated

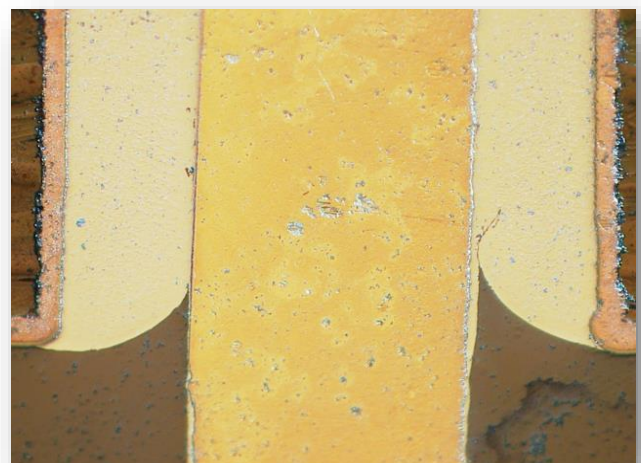
### **Unacceptable**

Evidence of solder not fully wetting the connector pin as it flowed into the plated through hole. Soldering parameters were not optimised for this laser soldered joint produced with SnSb alloy. Heat input to the PCB was probably more than the pin

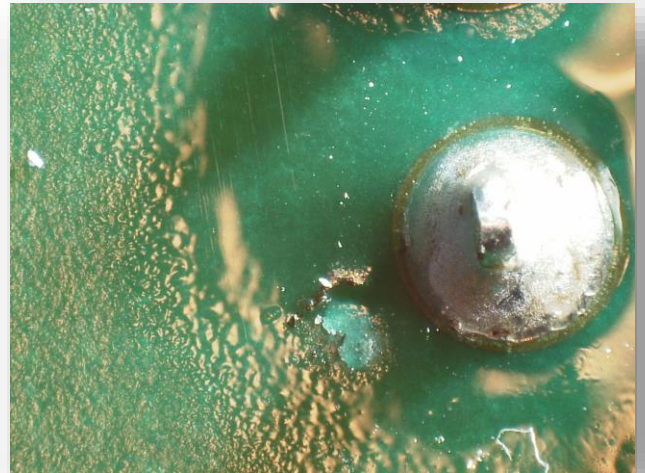
### Unacceptable

During automated iron soldering the program that defines the tip's contact position and force must be well refined. Due to change in position of the board, change of tip, poor product tooling or system drift, the soldering iron tip may cause damage to the board. The image shows damage to the surface of the solder mask caused by the tool

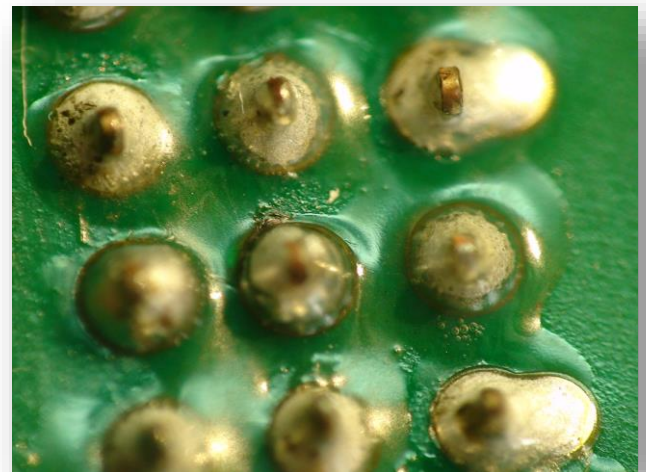
### Unacceptable

In most cases soldering with high temperature wire will generate much higher amounts of residue. The residues from different vendors' products can be soft or brittle and very easily displaced but not as soluble in cleaning solutions

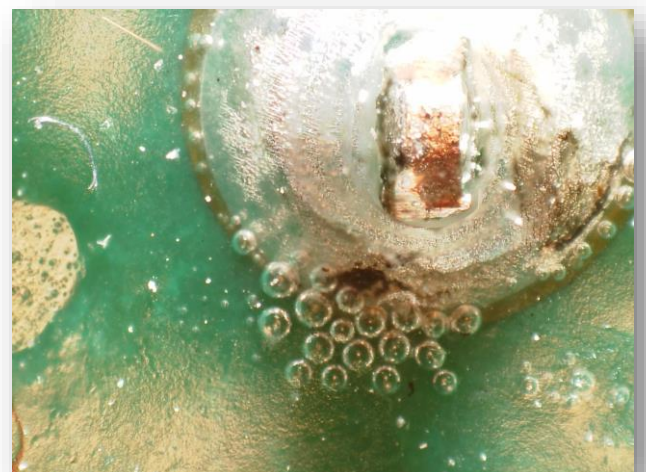
### Unacceptable

Bubbles most commonly seen on laser soldering are probably related to speed of temperature rise. If the flux is removed there should not be a problem. If the boards are conformally coated on flux it would be difficult to differentiate the flux bubbles with bubbles from conformal coating

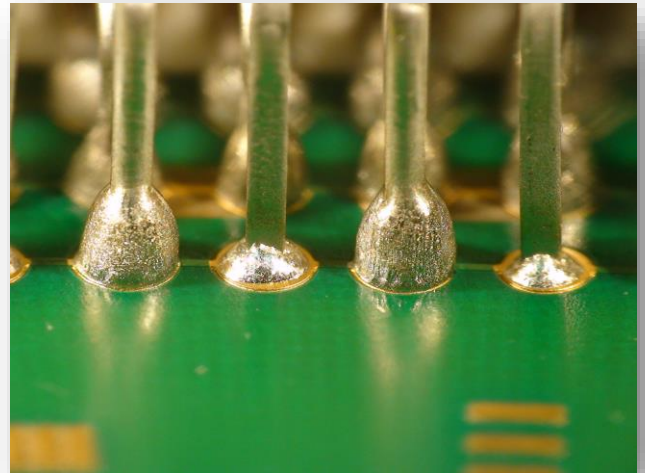
### **Unacceptable**

During automated assembly solder volume variation from pin to pin needs to be investigated. As the plated through hole size and thermal demand on boards are fairly consistent this is probably related to solder feed variations

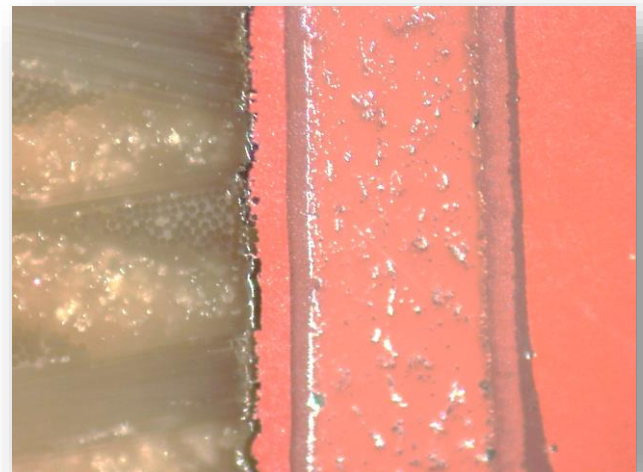
### **Unacceptable**

During soldering if excessive heat or long soldering times are used the copper barrel plating can separate from the fiberglass. This can occur where the adhesion of the copper is poor in manufacture, but in the example it was related to the soldering parameters used

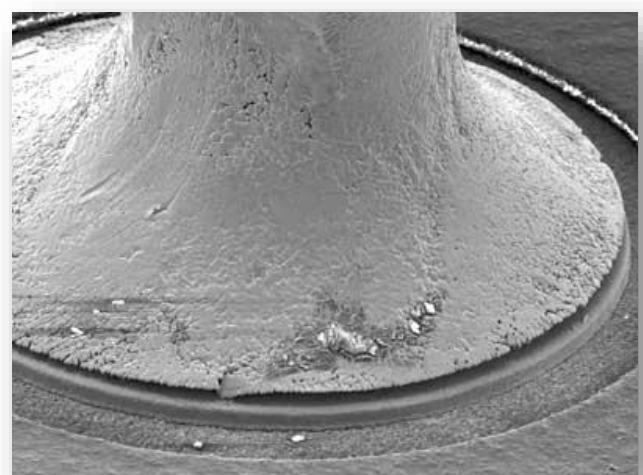
### **Unacceptable**

Solder fillet lifting was first experienced in lead-free soldering on selective, wave and intrusive reflow. It has not, to date, been seen to cause a reliability problem and not associated with all joints on a single board. It is mostly related to PCB expansion and contraction during soldering

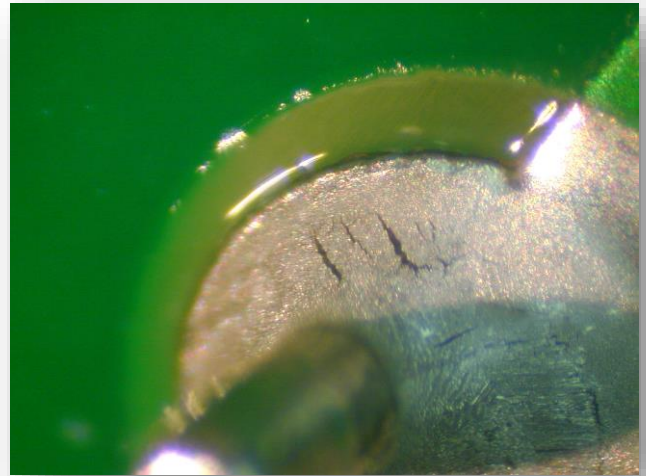
### **Acceptable**

Solder fillet tearing is a process phenomenon we have seen with different alloys. It is not seen on tin/copper but on SAC, more commonly on higher silver alloys. Tearing is seen on the surface of robotic laser and iron soldered joints but did not increase in size after static ageing or during temperature cycling

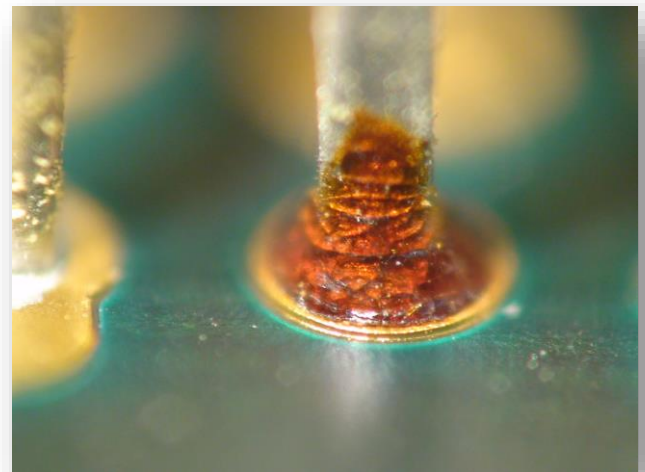
### **Acceptable**

Flux residues on the surface of joints after ageing at 200°C, it is the same appearance you would see with any high solids flux residues. It is the impact of high temperature storage on the inert residues. In the majority of cases products of this type would be cleaned during assembly

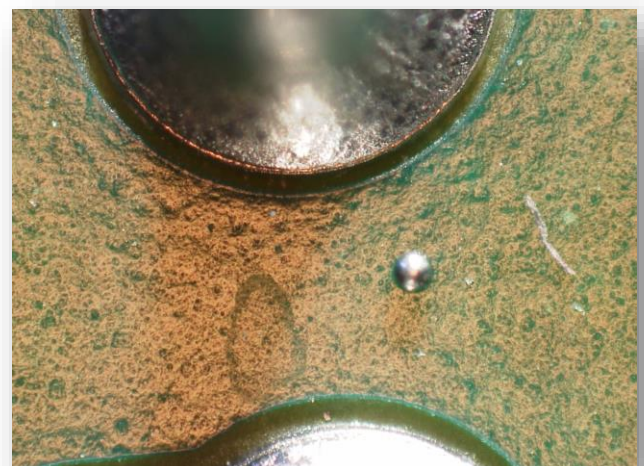
### **Acceptable**

Solder balls can be seen on high temperature selective soldering and can be eliminated. They are common with robotic laser and iron soldering but can be reduced. Take care in the selection of the wire, the process parameters, but most of all, pre-indenting of the cored solder wire

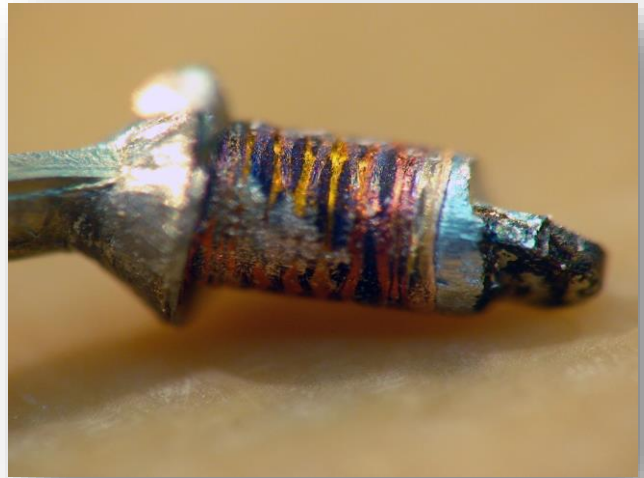
### Unacceptable

Plated through hole solder joint and barrel pulled out of the PCB during pull strength measurement. The surface of the copper barrel plating shows significant discolouration most likely due to overheating during contact soldering

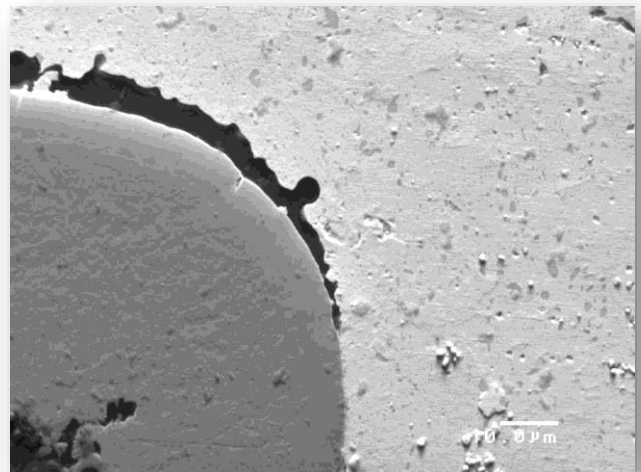
### Acceptable

Example microsection of fillet lifting on a SnSb solder joint. The solder joint and the intermetallic formed on the rest of the joint were satisfactory. It is not uncommon to see fillet lifting on high temperature joints. They are often not noticed due to the magnification typically used during manual inspection

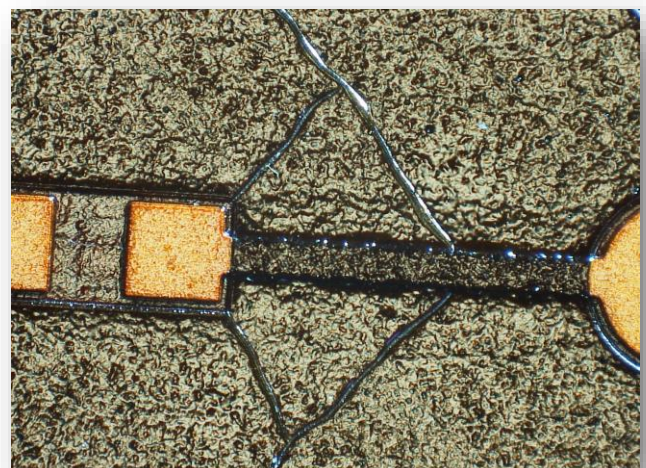
### Unacceptable

Conformal coating exposed to high temperature storage at 200°C shows evidence of cracking. Care need to be taken when selecting a coating for high temperature and the need for any pre-treatment to the boards prior to coating to get the best results

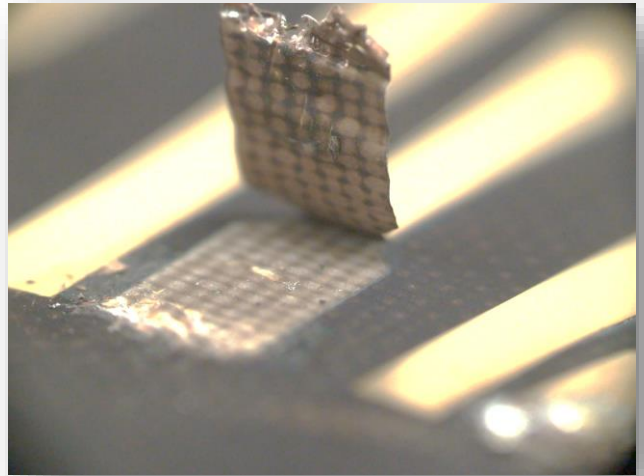
### Unacceptable

PCB track peel strength is affected by soldering temperatures and also high temperature storage. It is important to confirm the performance of the substrate material for these applications. The bond between the base laminate and the copper tracking had broken on this example

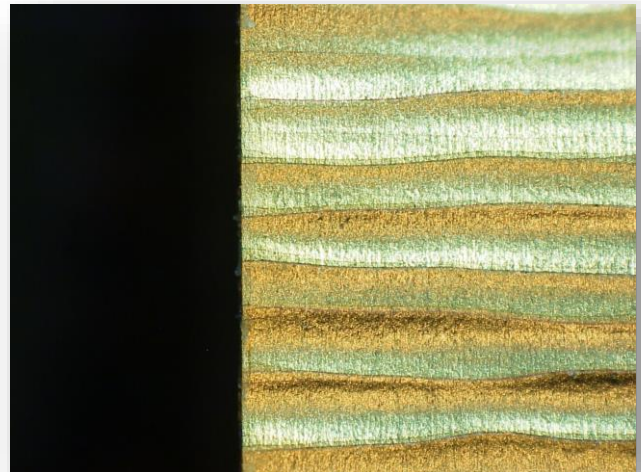
### Unacceptable

Exposing test boards with gold over nickel to high temperature storage then peel testing has shown nickel cracking. The example shows the track surface after peeling, during testing there is a distinct sound from the sample. It is not clear if the plating process has caused this effect

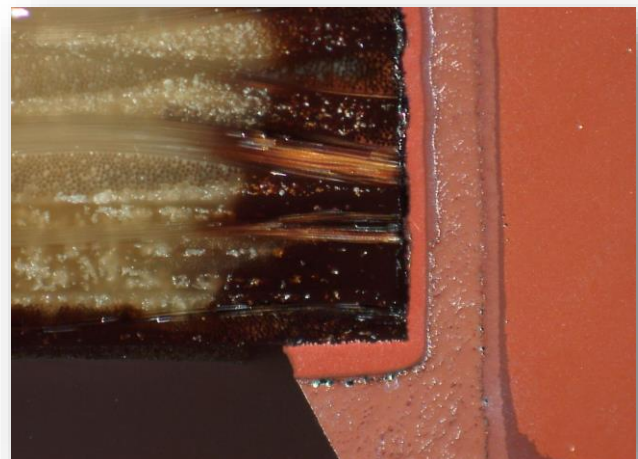
### Unacceptable

Microsection shows significant charring of the laminate around the joint area. This will have been caused by excessing temperature or the duration of the soldering operation. It can lead to reduces barrel strength and internal corrosion like CAF

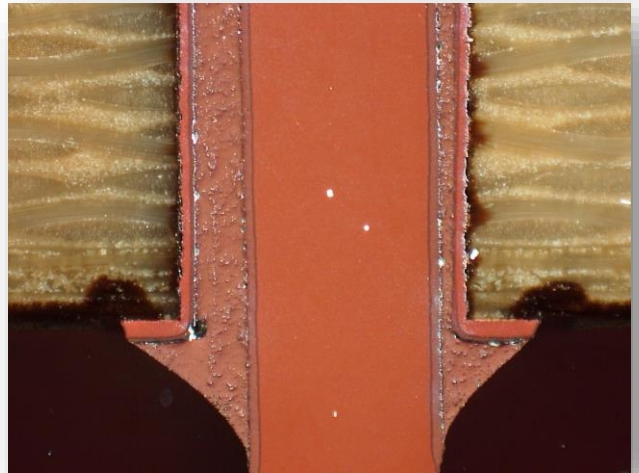
### **Unacceptable**

Microsection shows some overheating between the copper barrel and the laminate and more around the surface of the pad. This may be the result of incorrect laser soldering parameters or fluctuation in the process

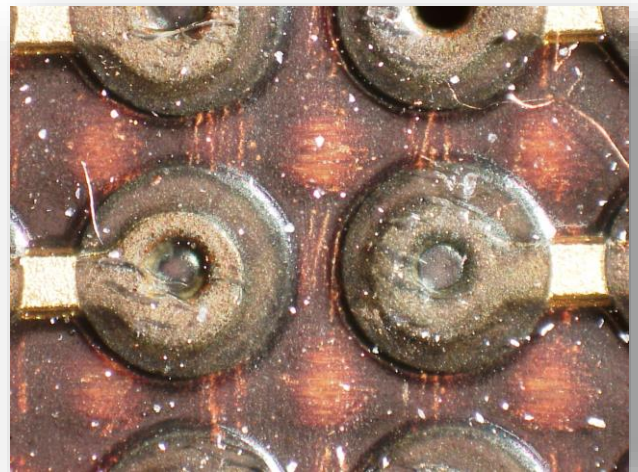
### **Unacceptable**

Example of high temperature laminate after exposure to 200°C for 1000hrs. There is evidence of the fibre bundles visible between 0.2mm via holes. The reason for this effect was not clear as the board had not been through an assembly process

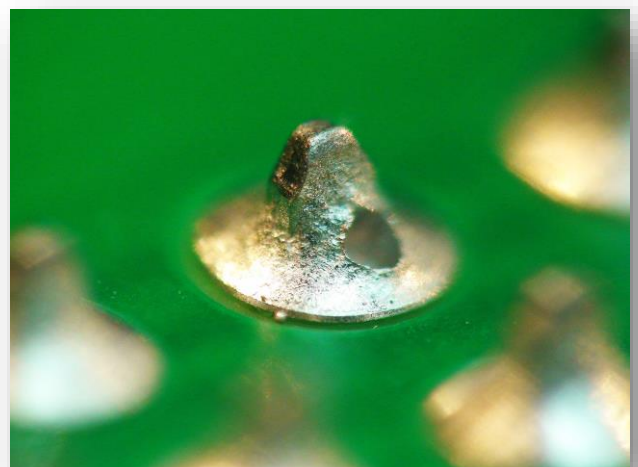
### **Acceptable**

Void in the solder joint due to outgassing during soldering which would have also resulted in solder spitting. Volatile material in the board will have outgassed through voids in the plating during the soldering process. With vapour escaping the solder solidifies and a void forms
