Guide to PCB Surface Finish Defects

Welcome to this SMART Group Defect Guide

Printed Circuit Board Surface Finish Defects

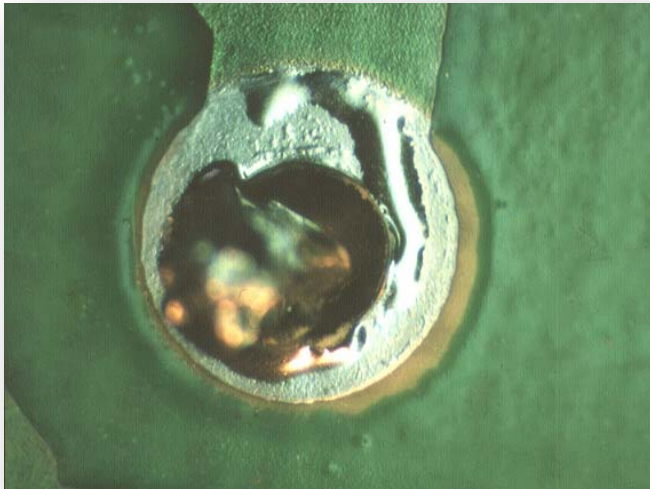
De-wetting on Pads

De-wetting of tin/lead solder on the surface of through hole pad may have been due to the copper pad preparation or the thickness of the solder coating in the original PCB manufacturing process. De-wetting is a less common defect today but is often misquoted in manufacture

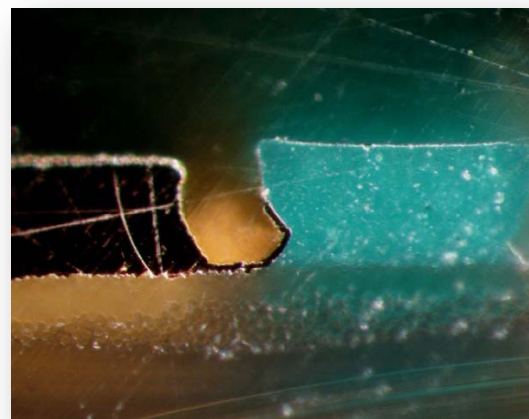
Nickel/Gold Foot

Nickel/gold foot is an unusual formation that can lead to shorts and reduction in surface insulation. The photograph shows a gold halo around the surface mount pads. Nickel has plated onto the surface of the laminate and the edge of the solder mask. This has also allowed gold to coat the surface of the nickel reducing the minimum design gap. Microsectioning of the nickel/gold foot clearly shows the plating defect. The nickel can be seen to extend from the bottom of the pad across the laminate and up the solder mask wall. This seems to be a more common process defect on PCBs and one that more users should discuss with their suppliers as an issue of quality control in board fabrication

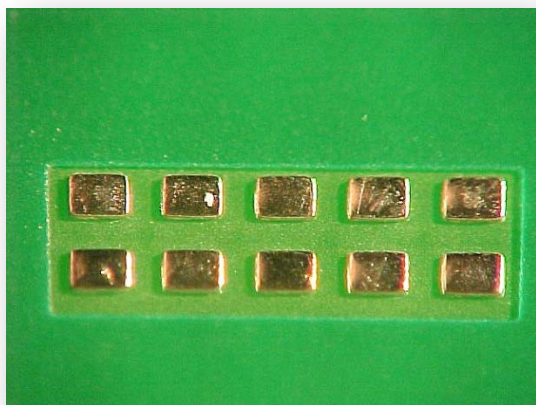
Solder Levelled Surface

Solder levelling has been a common process for tin/lead and also lead-free and depending on the supplier. The coating can work well for fine and standard pitch products with careful set up of the process. Solder levelling has had a bad name in some cases due to the limited amount of process engineering. Selecting the right combination of solder, flux and some experimenting the variation in solder coating thickness can be decreased. If the coating thickness variation can be reduced there will be less impact on printing, placement and potential yield. The two example groups of pads on the author's test boards are typical from a good supplier. In this case tin/copper/nickel alloy was used during levelling

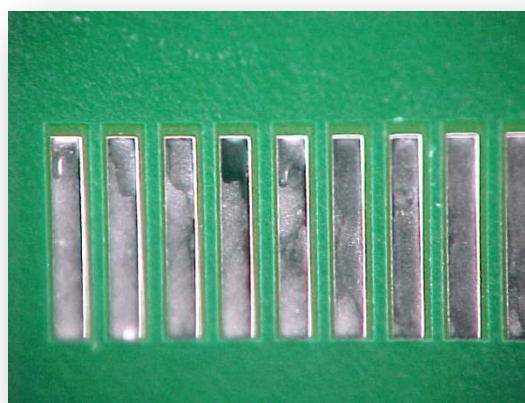
Solder Levelled Surface

The examples on 0.020" pitch pads show the droplet formation on the surface of solder levelled boards due to air knife pressure used to remove excess solder from the pads. This variation is considered minor and the board would remain solderable for six months in normal storage. With correct solder paste printer set up this would not impact the printing or place of parts on the board. If you are going to specify a solder levelled coating confirm the alloy and thickness variations. Don't just specify lead-free solder levelling as many users do

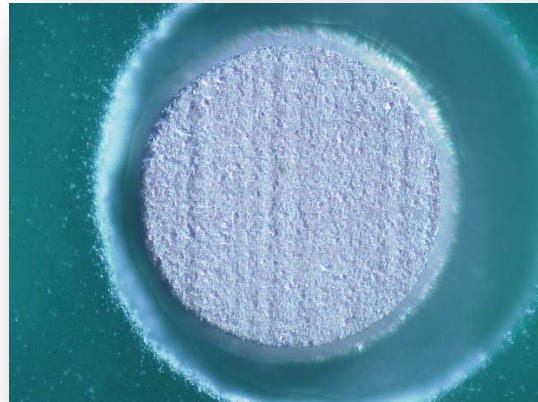
Poor Surface Preparation

Any surface coating does not perform as well if the copper surface below is subjected to a mechanical cleaning operation. The score marks on the surface of the pad are plainly visible on this copper OSP board. The poor surface treatment of the copper surface has been shown to impact the storage life of organic coatings as well as tin and silver and should be investigated. The mechanical cleaning marks are less obvious on the pad of the silver finish sample shown on the right

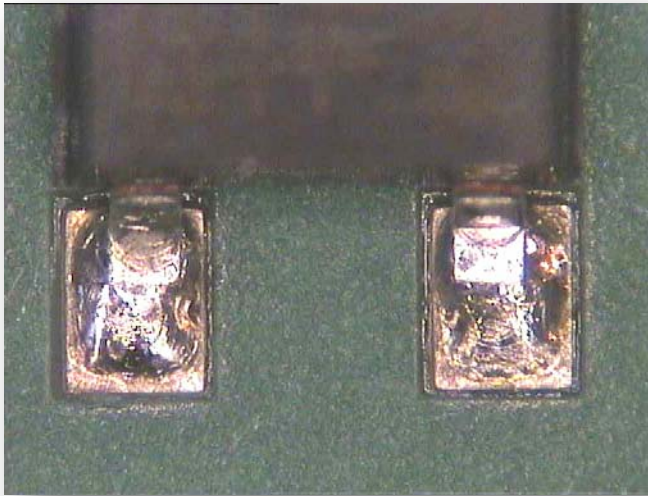
Reduced Solder Wetting

In a lead-free soldering process the degree of solder coverage may be reduced based on the solder finish, size of paste aperture printed, activity of the flux and the profile. In this case the solder has not wetted to the edge of the pad surface. However, a perfectly sound solder joint has been produced. When moving to alternative surface finishes the change in joint appearance must be understood by all departments to avoid unnecessary rework or rejection. It should also be understood by customers who are subcontracting products, exposed base material is not always an issue and is covered in IPC 610 Acceptability of Electronic Assemblies and IPC 600 Acceptability of Printed Circuit Boards

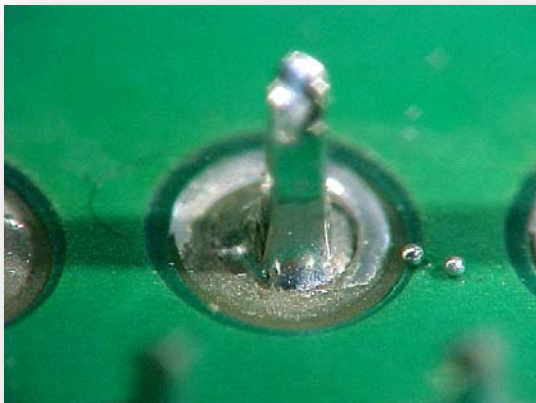
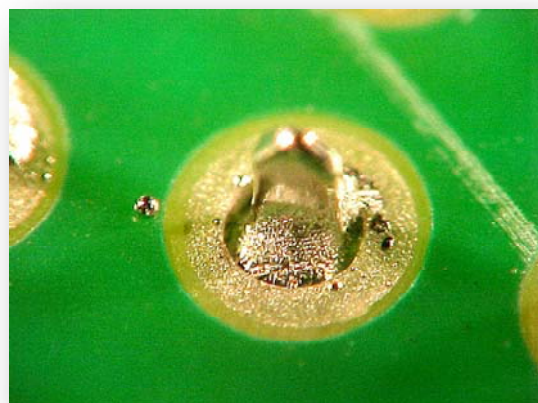
Copper Dissolution

The solder pad is missing from the through hole joints, a typical assumption would be poor rework. However, the pad has been dissolved during lead-free soldering. This can be due to a combination of the solder alloy, temperature, soldering time and solder flow rate. All surface finishes except for nickel/gold are susceptible to copper erosion. Solder levelling with some lead-free alloys can also reduce the copper thickness significantly even before the assembly operation and needs to be monitored. This problem was first seen on lead free rework using solder fountains then experience with selective soldering before the problem was full examined. NPL has two documents specifically looking at copper dissolution during soldering with different lead-free alloys and can be downloaded Free <http://defectsdatabase.npl.co.uk>

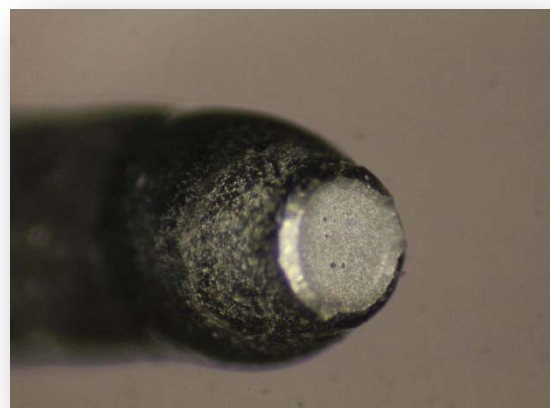
Champagne Voiding

Voids in the solder joints are not uncommon after reflow soldering and can be easily detected using x-ray. Champagne voiding is related to hundreds of very small voids seen at the solder joint to surface pad interface. Normally in reflow voiding may be related to the paste and profile. The voids will be seen in the bulk of the solder joint or near the top of the joint at the component pad interface. Champagne voiding was originally seen on silver coated boards and related to the organics gassing during reflow soldering. This problem was overcome by both chemistry suppliers to the industry. However, the author has seen a few recent cases in one automotive supplier

The second image on the right shows a ball pull test conducted on a DAGE heated stage to examine pad cratering between PCB pads and laminate but has also been used by the author to examine voiding on joint interfaces. It may be possible to compare the degree of voiding at the interface with joint strength. The ball pull test can be very valuable to assess the impact on joints

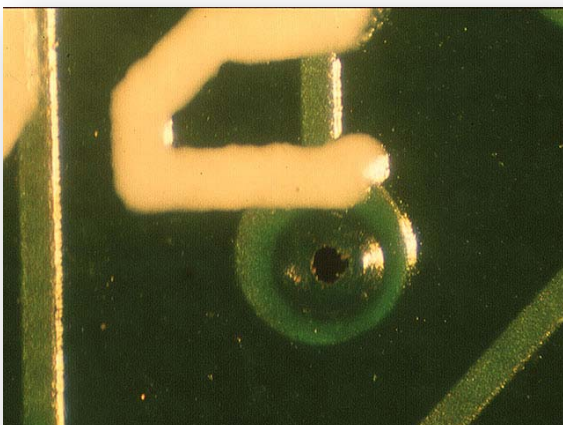
Via Holes Popping

When solder mask is applied over a via hole sealing the barrel outgassing can cause the resist to pop during solder levelling. The resist blister may seem just a cosmetic problem but it can affect solder paste printing on fine pitch boards. The resist locally lifts the stencil from the surface of the board. The appearance of lifting or cracking of the solder mask may be affected by the type of mask, one that is either brittle or flexible

Gassing may occur during solder levelling, reflow soldering and wave soldering. Wave soldering should be less of a problem but second side reflow would be an issue for the process engineer. Either the air trapped in the barrel of the hole or outgassing from the hole wall will cause this problem and it can also cause solder balls on the top of vias if the levelling process is attempting to fill the vias. In high reliability applications and thickness multilayer boards vias are sometimes filled with epoxy then capped with solder mask. However, experience shows that vias can still outgas during reflow
