# *Guide to Conformal Coating & Cleaning Defects*

## Conformal Coating & Cleaning Defects

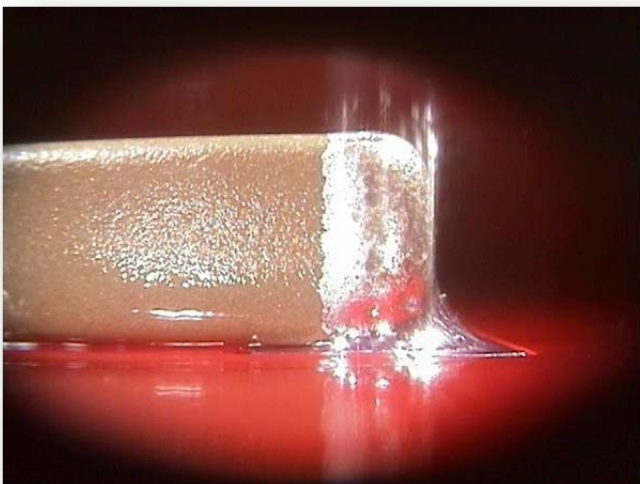
### Satisfactory Coating

Satisfactory coating on the surface of a board assembly, but it's not possible to easily identify the successful coating process without a UV trace in the coating. This example does not appear to have a layer of coating over the body of the capacitor. The majority of all coatings now allow inspection by UV light. There are no UV traces in this Parylene coating which can make inspection difficult; however, due to the coating process coverage is assured. It is the inspection in areas that have to be masked that then become a challenge after de-masking operations.

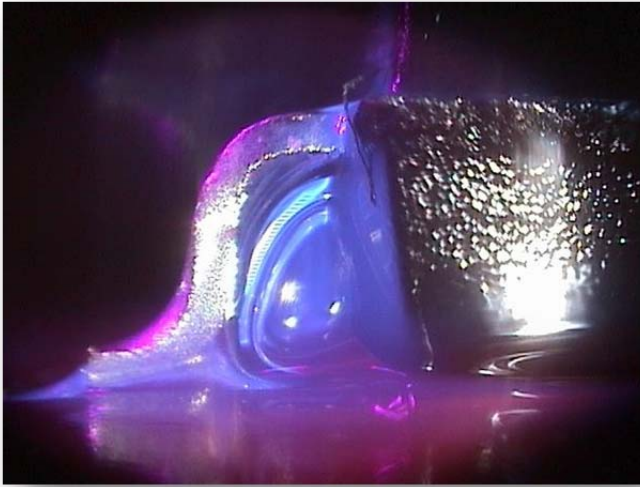
### Satisfactory Coating

Satisfactory dip coating of this SOIC is shown during inspection under UV light. The coating has completely covered the surface of the board, terminations and body of the component. If a spray coating process were used all the surfaces would be coated to an equal standard but there would not be coating filling the gap between the component termination and body. It's always important comparing like for like.

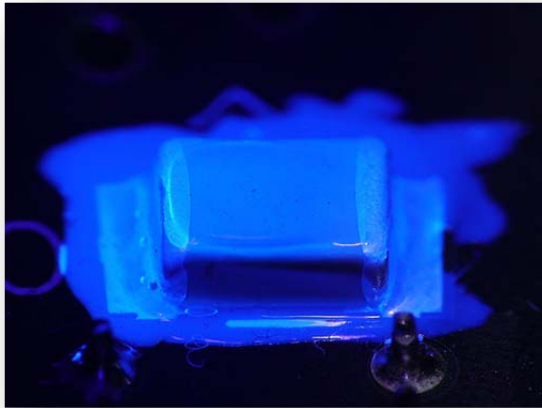
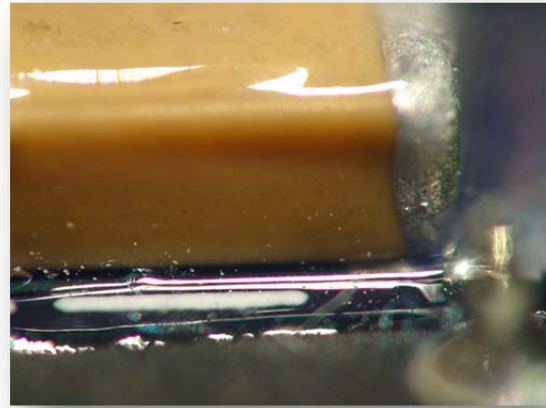
### Selective Conformal Coating

Two examples of manual selective coating the one on the left is under UV light. It is clear that the image on the left has been added manually but, provided it meets the requirements of the design, is satisfactory despite the uneven coating border. The close up image on the right shows the coating has fully covered the capacitor and its terminations.

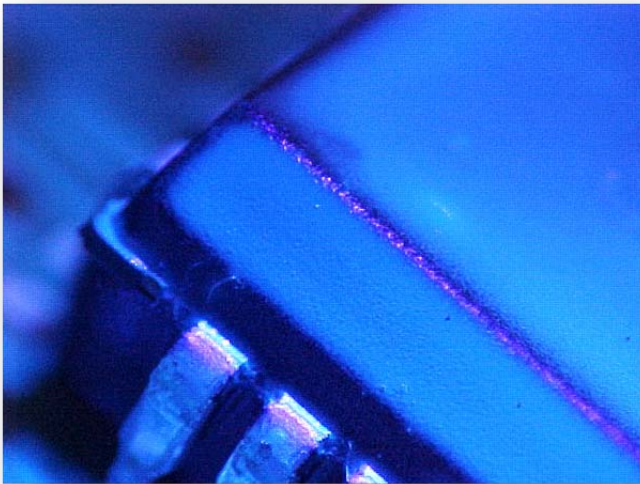
### Satisfactory Coating on PLCC

Coating on sharp corners can be difficult. The flat surfaces of this PLCC device shows satisfactory coating. Provided the surface of the board and all terminations and separation gaps between adjacent exposed pads are coated the reliability of the product should be satisfactory. However, based on many standards no coverage or edges of plastic parts would be considered unacceptable. It is felt that inspection standards and criteria do need to be regularly reviewed and updated. To achieve a better coverage on devices like this it would be necessary to coat the board assembly again but also look at the viscosity of the material being used. If the solids content was low it may have reduced the coatings coverage.

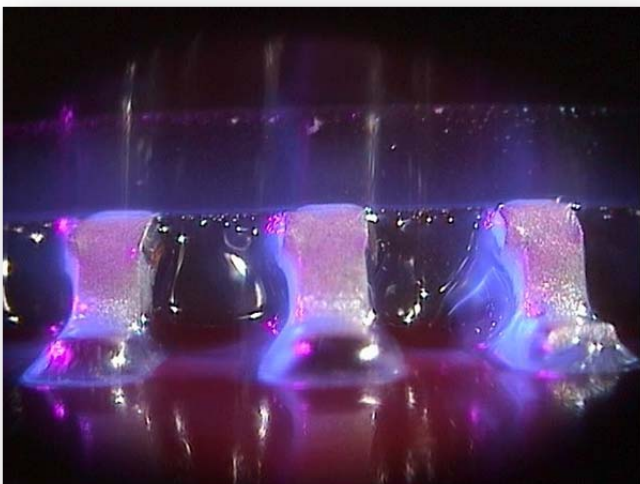
### Satisfactory Coating on SOIC

Coating is satisfactory and is shown under a UV light source. There is good coverage on the component leads, component body and the surface of the board between the 0.050" pitch terminations.

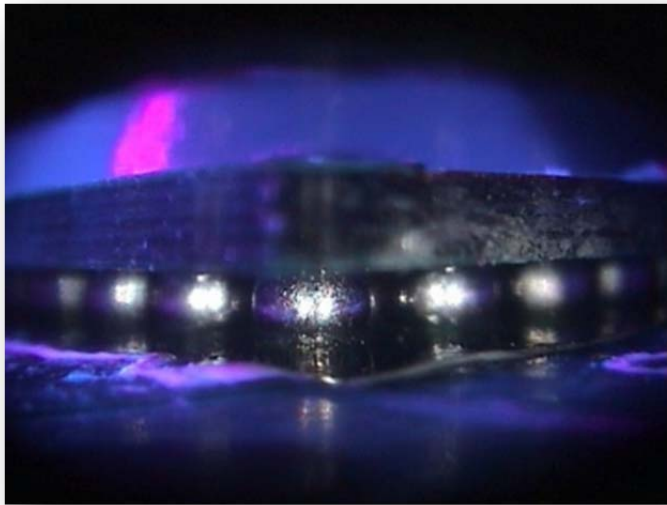
### Satisfactory Coating

Coating inspection under UV light shows satisfactory coverage on the surface of the BGA and board assembly. However, there is little penetration under the BGA with spray coating. Dip coating will help penetration under the area array component if that is what is required. However, a slower entry speed and dwell time will be required in the tank. Time must be allowed for the coating to penetrate fully and displace any air.

Care needs to be taken with the choice of coating materials if coating under these parts is actually required. Selected coatings can have a high expansion rate during thermal cycling and could lead to solder joint damage.

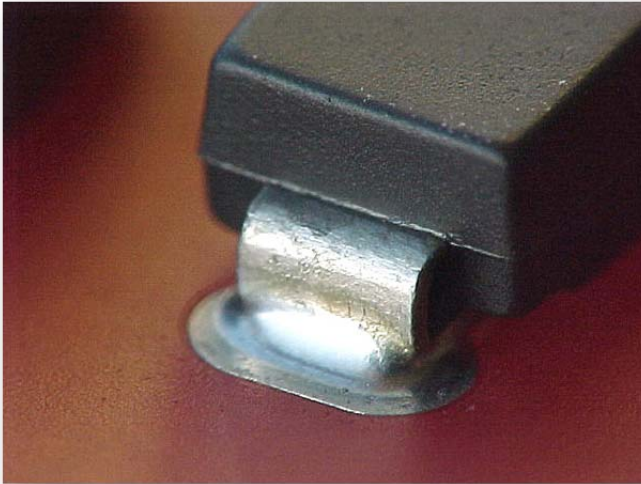
### Satisfactory Coating

This board assembly has a Parylene coating which is around 15um in thickness on all surfaces of the board and components. Based on the process the coverage and thickness is virtually guaranteed. It is however difficult to see the coating due to the process and the type of material used. There is generally no UV trace in this material, however some suppliers are now able to provide it on selected types

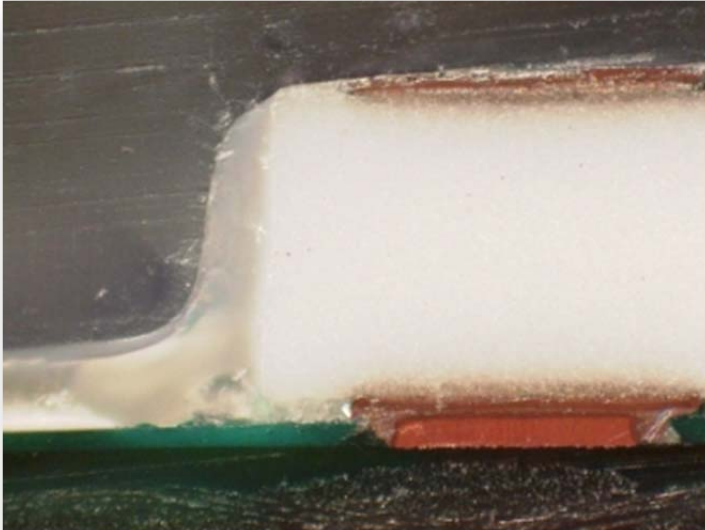
### Conformal Coating Coverage

The image shows a microsection of a chip component on the surface of a printed board after coating and cure. Epoxy resin has been used to hold the sample for grinding. The coating thickness on the side of the chip is thick and on the sharp edge of the ceramic part the thickness is significantly reduced. This is no different than any other example you may examine. Changes in the process parameters and materials could increase or decrease the coating thickness on the board assembly.

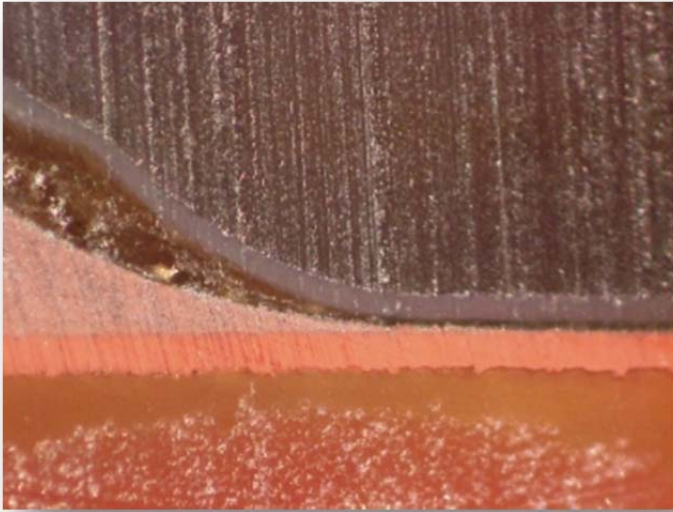
### Conformal Coating Coverage

Coating coverage on this microsection shows the potential performance advantages of Parylene coating. The image shows the coating which is between 20-30um directly over the surface of the board, solder joint and reflow paste flux residues. The flux residues are the brown material appearing to lift the coating, however, the coating is actually just following the contour of the residue.

There are very few technical research reports on flux residues on the surface of boards after conformal coating. Often people focus on the flux and its possible corrosion under the coating; however, the thickness of any inert residues can expand and move under the coating possibly leaving voids. This in turn allows moisture to form in the voids and remain in place, which can then cause failure. This is more difficult to define, reactive flux residues are easier to research and monitor.

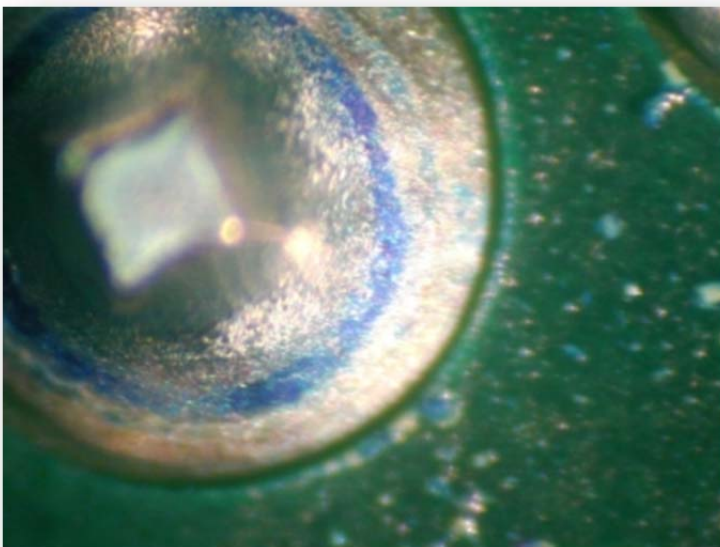
### Flux Residue Testing

Basically the test fluid is placed on sample areas of the board assembly or on selected joints. The fluid must be left on the surface of the test feature for a fixed period of time for a reaction to take place. There are two different fluids, one for activators and resin systems. In the example a through hole termination produced by selective soldering has been tested for flux activators. The change in colour to a blue deposit shows a positive result indicating there are activators still present on the solder joint surface. Blue residues can also be seen around the joint on the solder mask. A company would need to establish their own criteria between this test method, cleanliness results, SIR reliability data and possibly product exposure to specific operating environments.

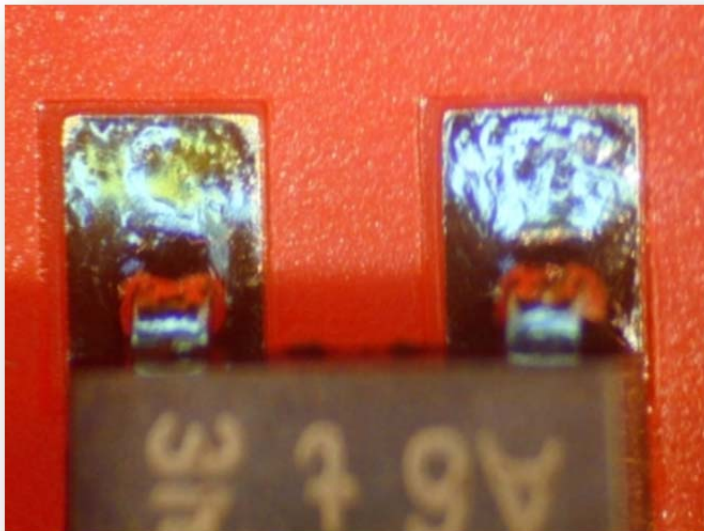
### Flux/Resin Residue Testing

In the example SOT23 terminations produced by reflow soldering have been tested for resin. The change in colour to a brown deposit shows a positive result indicating there is contamination still present on the joint surface. A company would need to establish their own criteria between this test method, adhesion, cleanliness results, SIR reliability data and possibly product exposure to specific operating environments.
